Investigation of Solution Collapse Breccia in Mature Salt Cavities

Michael G. Jaron,
Wyandotte Chemicals Corporation
Wyandotte, Michigan

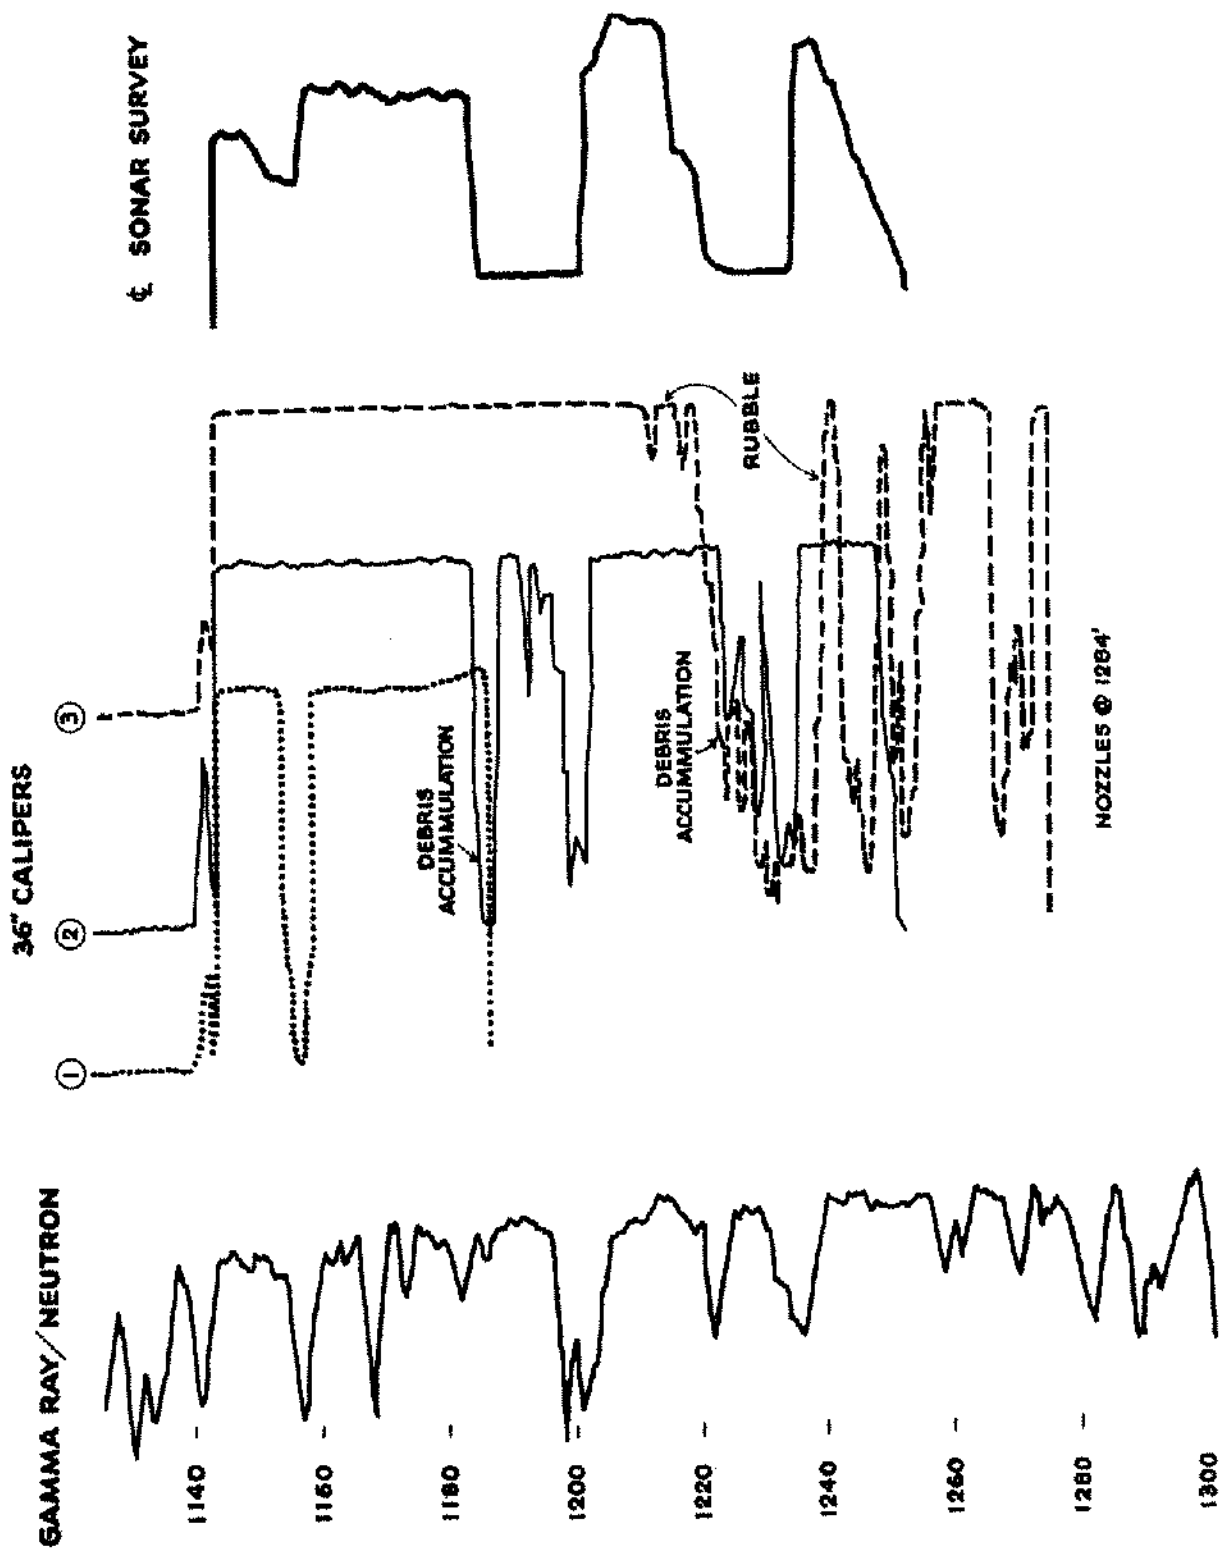
A series of wireline surveys made in connection with the development of an LPG storage cavity in the B unit of the Salina group is shown in Figure 1. At the far left is a portion of a gamma ray/neutron log. Excursions to the right represent salt layers, and to the left, shale-bearing dolomite and anhydrite-bearing dolomite. In the middle of Figure 1 are three 36 inch caliper logs, the first of which was run after removing about 440,000 cubic feet of salt and the last run four months later after having removed an additional 160,000 cubic feet. Solution of the salt was accomplished by tubing injection through a series of nozzles set at 1284 feet, with a nitrogen pad used to prevent roof scalping.

The caliper log, within the range of its arm expansion, delineates zones of solution, collapse and debris accumulation. The first caliper log shows three ledges at 1138, 1157 and 1186 feet; salt and insoluble rock between these ledges appear to be washed out. The second caliper log run one week later shows the ledge at 1138 feet to be still in place . . . probably the result of nitrogen padding, and the ledge at 1157 feet to have collapsed, with debris accumulating on the ledge at 1186 feet interpreted by observing the ledge to have moved up hole. A portion of a sonar survey (vertical and horizontal scales are equal) run on the following day is shown at the far right of Figure 1. It agrees favorably with the second caliper log in that it reflects cavity and ledges. The sonar survey, because of its greater range, shows that the collapse at 1138 feet extends some 17 feet out from the cavity's center, whereas the caliper could not show collapse beyond the range of its 36 inch arms. However, where the second caliper log shows the beginnings of solution between the ledges at 1186 and 1193 feet, the sonar survey shows none. This serves to delineate the lower end of the sonar sensitivity range and that the caliper log may depict incipient ledge undermining to better advantage. The third caliper log shows the ledge at 1138 feet is in place, but collapse of the ledges at 1186 feet and 1193 feet has occurred with debris accumulating on the ledge at 1220 feet. The third caliper log also picks up rubble in areas which were shown to be open hole in the second caliper log. Insofar as the nozzles were set at 1284 feet, we assume that below this depth to the bottom of the salt are open hole and rubble filled cavity. As more salt is dissolved out, we would expect the cavity to fill with rubble. That this does indeed happen was borne out in a waste disposal project initiated in 1966.

Figure 1. Progression of solution, insoluble ledge collapse and debris accumulation in a cavity being developed for underground LPG storage as shown by wire line surveys.

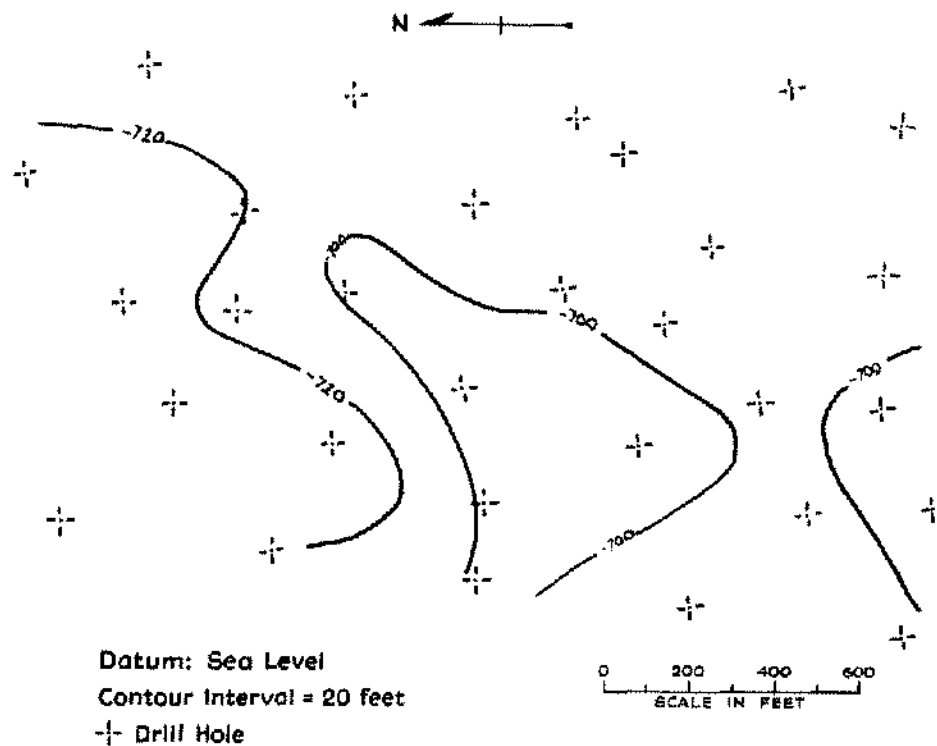
Figure 3. Structure map on base of Salina Unit B showing little structural relief and a slight northerly dip.

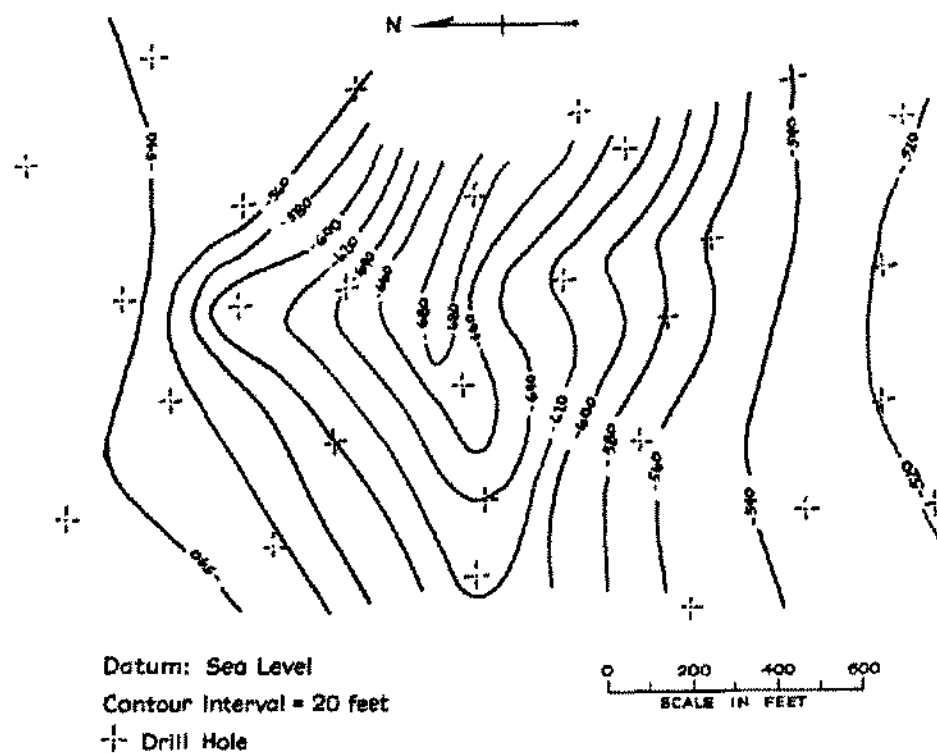
A solution collapse structure, thought to be older than the Salina Unit D, involving the "B" and "C" units of the Michigan Salina has been investigated. Within a 40 acre area "B" salt thins from about 190 feet to less than 20 feet and the thickness of the overlying insoluble unit (Unit C plus "B" rubble) increases from 140 to more than 290 feet. A structure map on the base of Unit B (Fig. 3) shows a slight dip to the north and little structural relief. A structure map on the top of the "B" salt (Fig. 4) shows the salt to be deeply sculptured by solution, thought to have occurred during "B" and "C" time. Within the area shown by our data points, we can see one distinct channel; others probably lie outside of the area covered. This channel has its "head" in the down dip direction implying, in this area, subterranean updip solution. A structure map on the top of Unit C (Fig. 5) shows little relief, the deeply sculptured "B" salt being filled in by the time that Unit D was deposited, thus dating this event as being contemporaneous with Units B and C, but older than Unit D. A core taken in the middle of the solution feature shows intense brecciation for a distance 90 feet above the salt top. Figure 6 shows an example of the breccia. The groundmass varies, but in Figure 6 it is largely a shale-bearing dolomite with sub-angular to sub-rounded fragments of dolomite and anhydrite. Some of the dolomite fragments are pitted or are wafer-like where interbedded salt has been leached out. These fragments are probably remnants of insoluble stringers which are common in Unit B. Fifty feet of this breccia is clearly Unit C, the remainder being jumbled Unit B rubble. The fifty feet of Unit C has retained its gamma ray/neutron identity and is readily traced throughout the solution structure, its thickness being constant. Brecciation stops in a ten foot thick breccia bed in Unit C. Above this bed is a thickened Unit C (shaly-dolomite with minor anhydrite) section.

Cross bedding and cut-and-fill structures are found indicating a shallow water depositional environment. A structure map on top of the uppermost brecciated anhydrite mirrors Figure 4, top of the "B" salt. This infers that intensive solution did not begin until the uppermost breccia anhydrite bed was deposited.

Figure 4. Structure map on top of Salina Unit B salt showing solution structure.

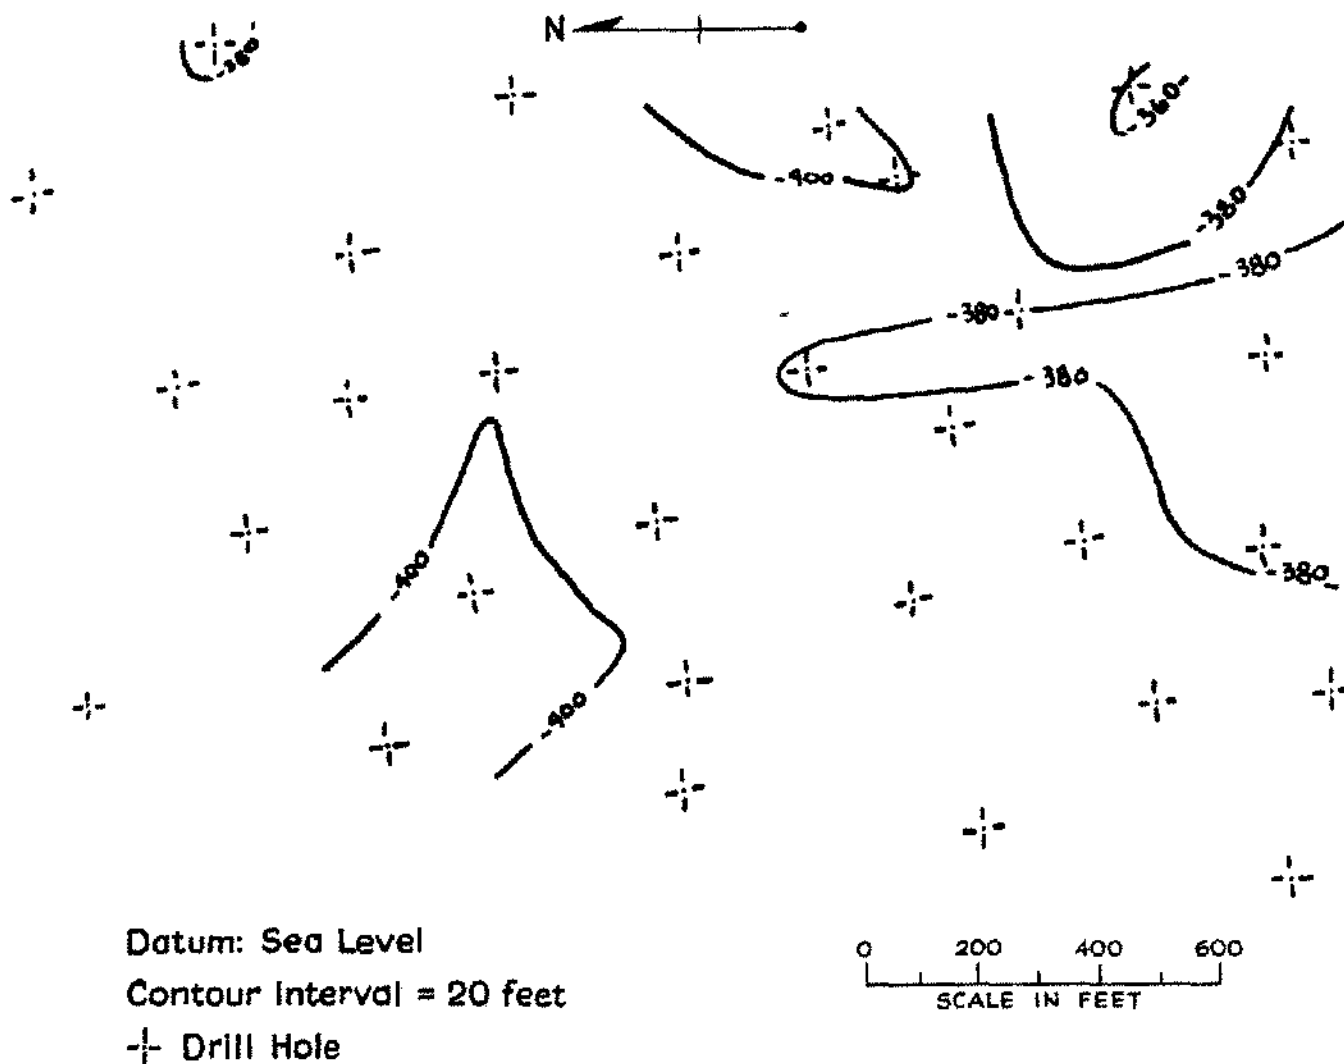
Figure 5. Structure map on top of Salina Unit C showing little structural relief, dating "B" salt solution structure as being older than Unit D.

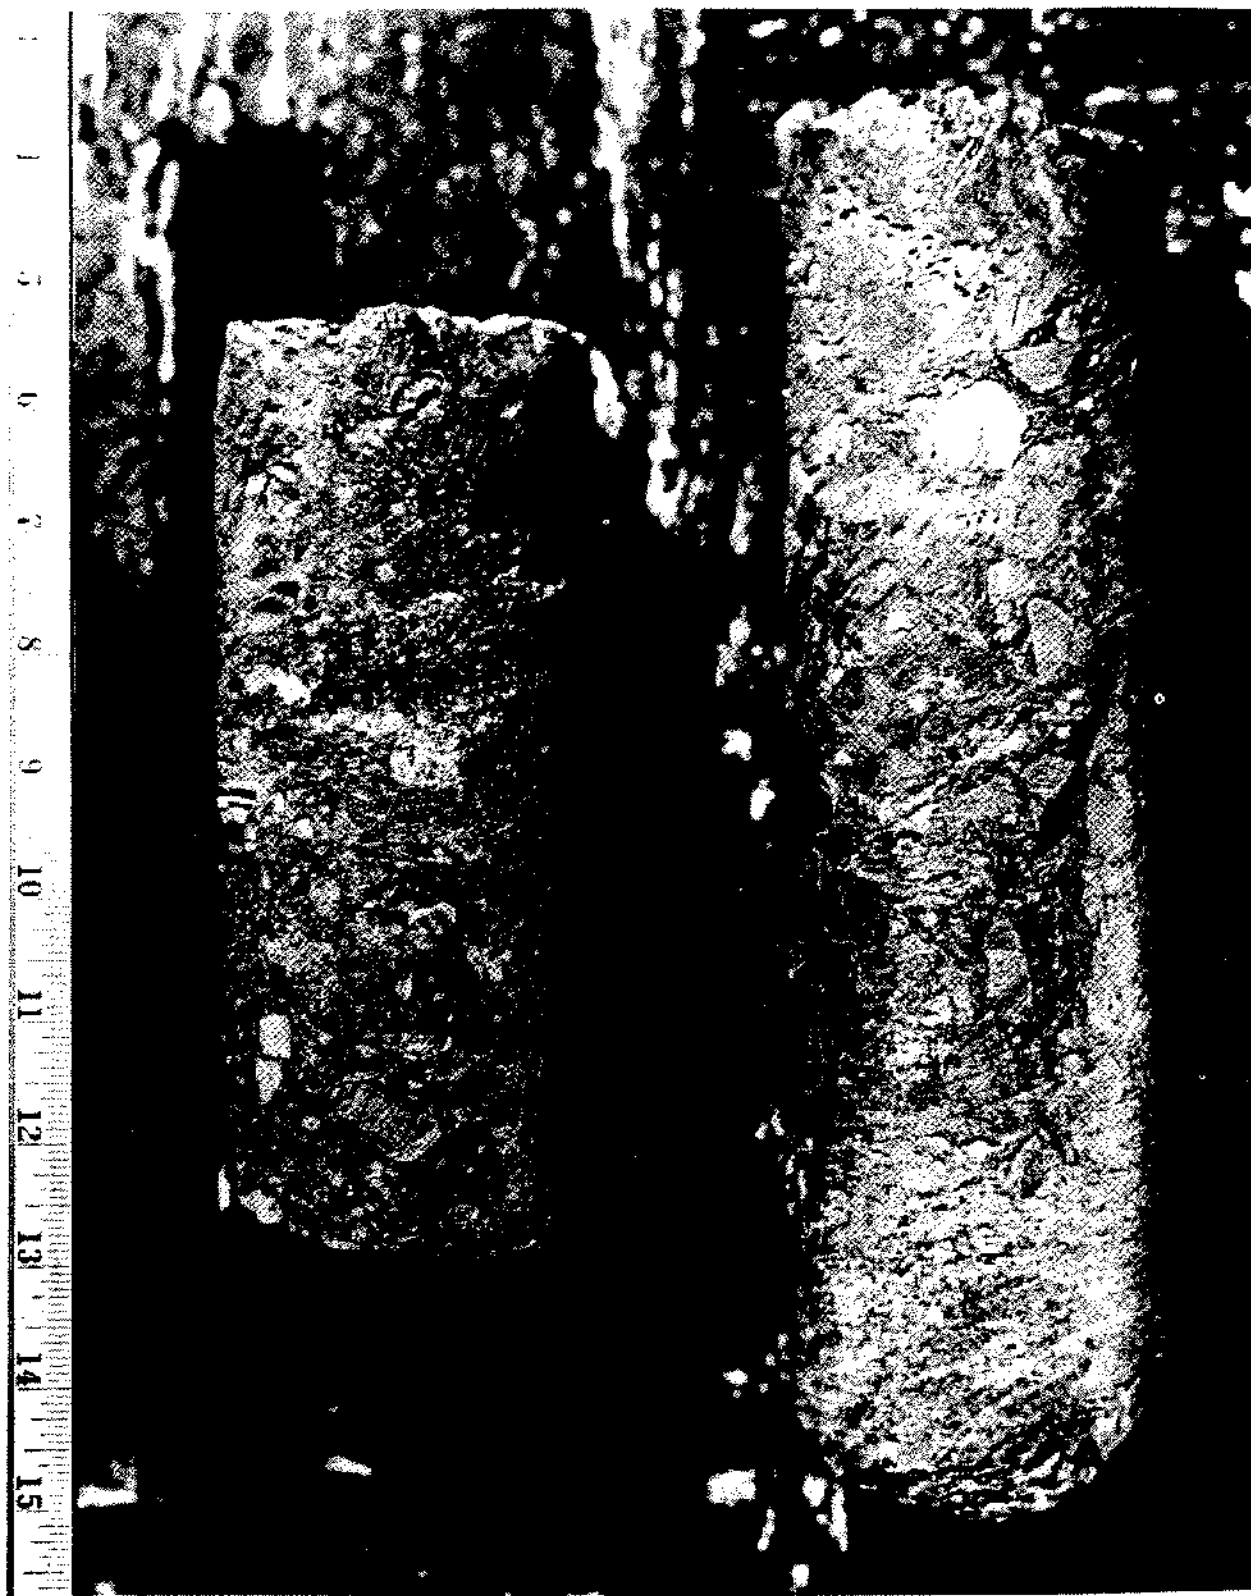
Figure 6. Example of solution collapse breccia as shown by core cut in drill hole located in the center of solution structure.
