# The Flooding of the Cominco Potash Mine and its Rehabilitation

Fritz F. Prugger

*Cominco Ltd., Potash Operations, Vanscoy,  
Saskatchewan, Canada S0L 3J0*

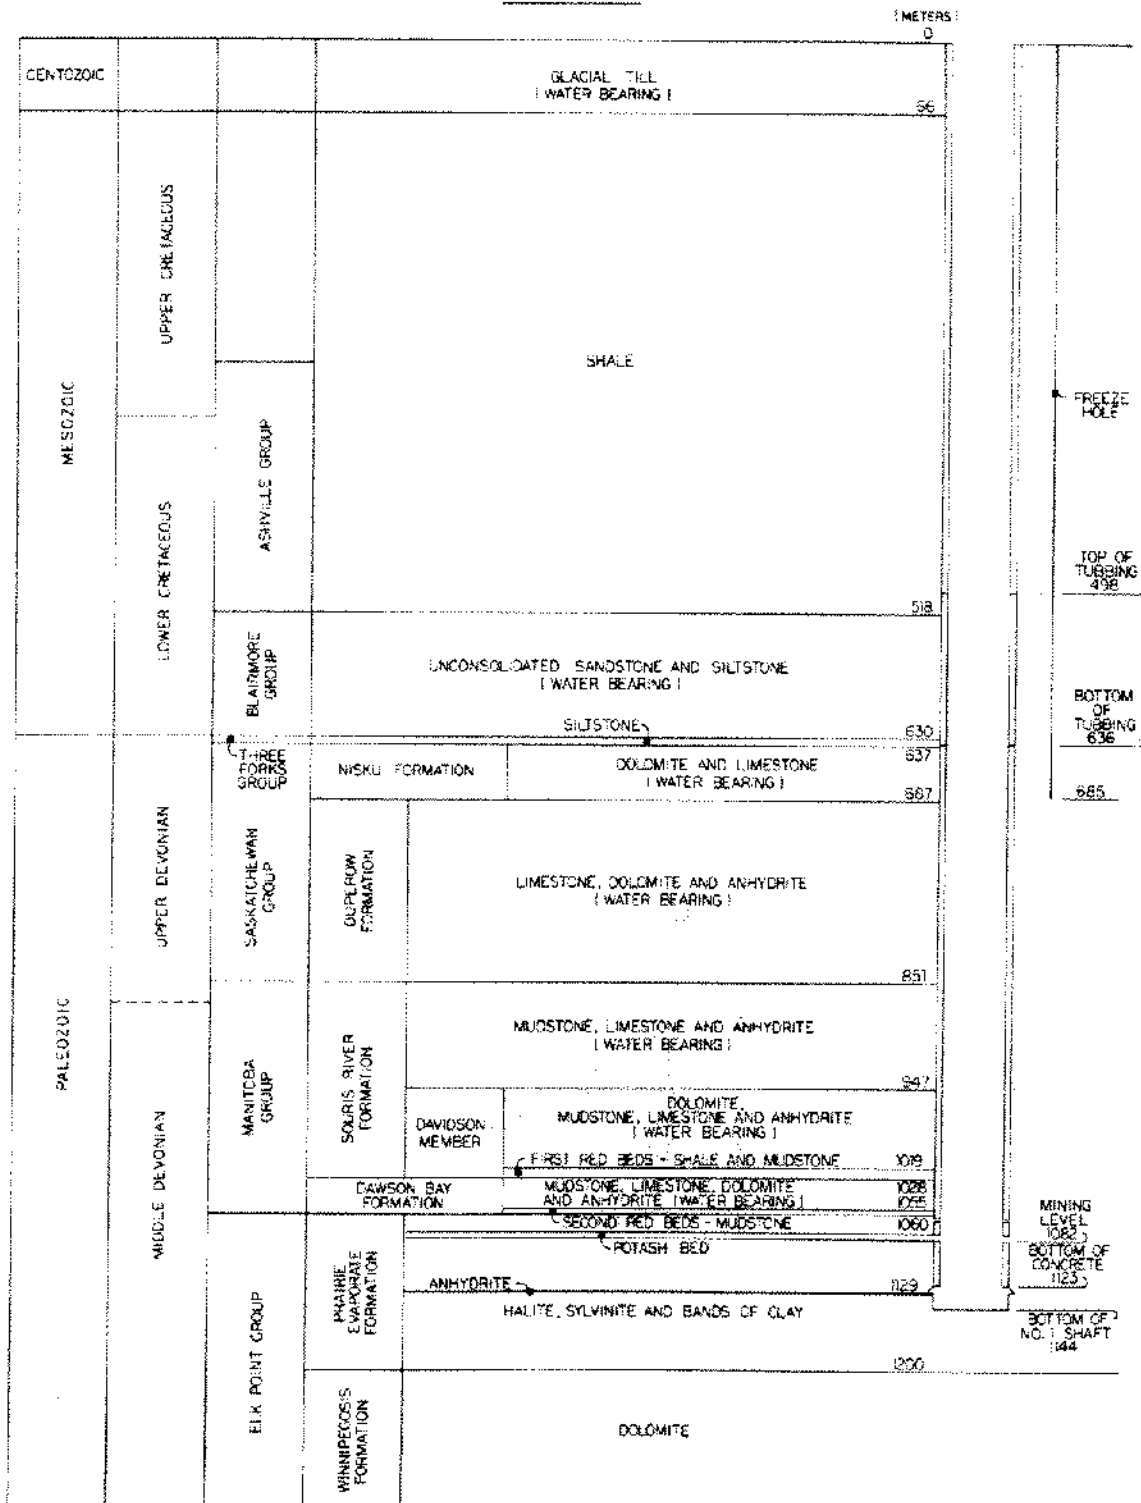
SECTION SHOWING NO. 1 SHAFT  
IN RELATION TO FORMATIONS  
CHART NO. 1

Figure 1. Section showing No. 1 shaft in relation to formations.

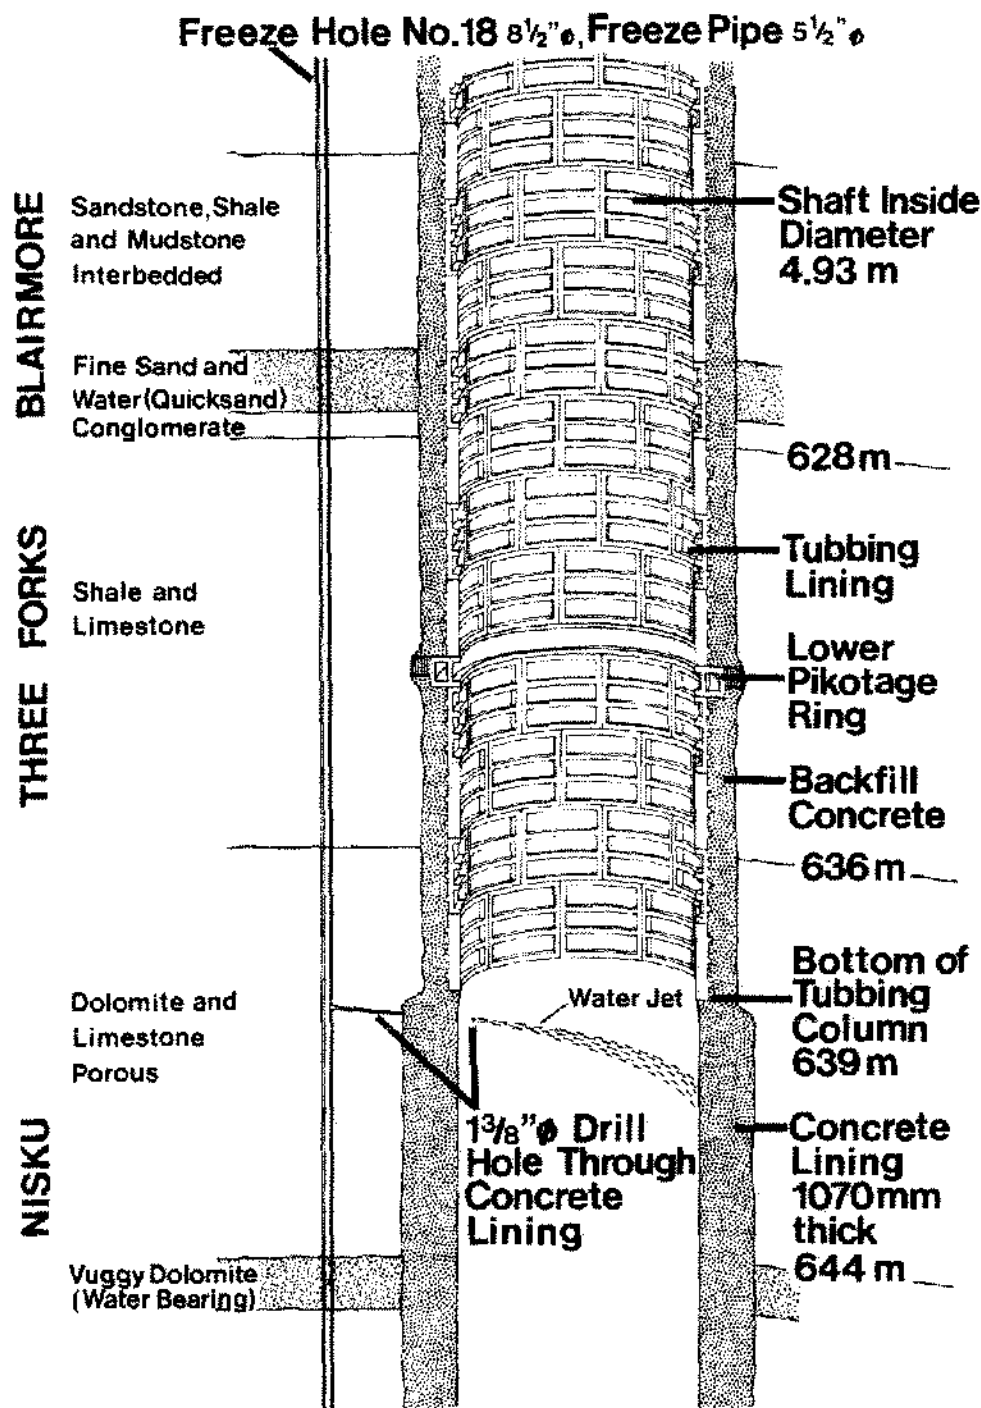
During routine grouting of the concrete lining of the No. 2 Shaft, a major water source was intersected about 50 cm below the lowest tubing ring at a depth of 639 m. Water and sand under very high pressure entered the shaft through a 35 mm drill hole in a 50 mm standpipe in the concrete shaft lining at a rate of about 4 m<sup>3</sup>/minute (Fig. 2).

An immediate attempt to halt the water inflow by attaching a shut-off valve to the standpipe failed. Within three hours the standpipe had broken loose and within six hours a hole, about 75 mm in height and 350 mm in width, had developed through the shaft lining. The water inflow had increased considerably. Since the enormous inflow of water and quicksand could not be stopped, the major pieces of underground equipment were moved into protected areas and about 10 hours after the first inrush of water the mine was evacuated.

Figure 2. Cominco Shaft No. 2. Break through concrete lining at depth of 639.43 meters.

A heavy steel plate equipped with a pipe manifold and high pressure shut-off valves was positioned over the break, jacked tight and bolted to the concrete wall. With the help of the valves it should have been possible to control the water inflow while the leak was sealed by grouting. Two 250 mm heavy-duty wide-flange I-beams, 5 m long, were bolted to the three bottom rings of the tubing column. These two beams formed the guides for another set of heavy steel beams, which provided the frame for the shut-off plate. A 200 mm pipe manifold with twelve 50 mm high-pressure valves was welded to a 40 mm steel plate 915 mm high and 870 mm wide (Fig. 3). This plate was bolted to the frame and the whole assembly could slide in the guide beams like a guillotine gate. This gate assembly was pushed into position over the break and secured with two 50-ton hydraulic jacks that were braced against the opposite shaft wall. An attempt to install a third jack had to be abandoned. Although much of the water came through the valves, the pressure and volume of water outstripped the valve capacity and water still forced itself out around the plate.

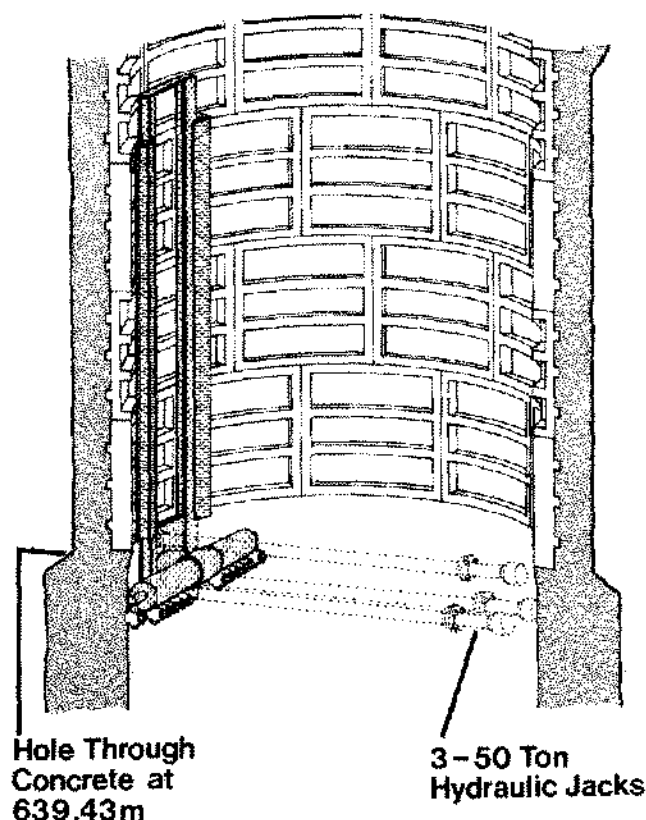
Figure 3. Guillotine gate, support guides and hydraulic jacks.

Preparations were made to bring the water inflow under control from within the shaft by the construction of a guillotine gate and by grouting. All work in the shaft was extremely difficult. Not only was there the jet of water and sand but there was also the roaring noise and the tremendous suction of air created by the mass of water hurtling from the 640 m level in a free fall of 440 m to the shaft bottom forming a natural compressor. A heavy bulkhead was installed at the collar of No. 1 Shaft to counteract the air flow in No. 2 Shaft and to make it possible for workmen to enter the shaft. In addition, whenever critical work was performed, brine was pumped down the No. 1 Shaft to reduce the suction in No. 2 Shaft.

In No. 2 Shaft the guillotine gate was exposed on October 25th. There were no leaks from around the plate. Eight core holes were drilled through and around the plate to test the effectiveness of the seal. The breach was completely plugged. The pipe manifold was then removed and the plate was bolted to the concrete wall. During the next two months, grouting of the formation from the bottom of the rubbing to the wet Nisku Zone at a depth of 652 m was undertaken through the shaft lining.

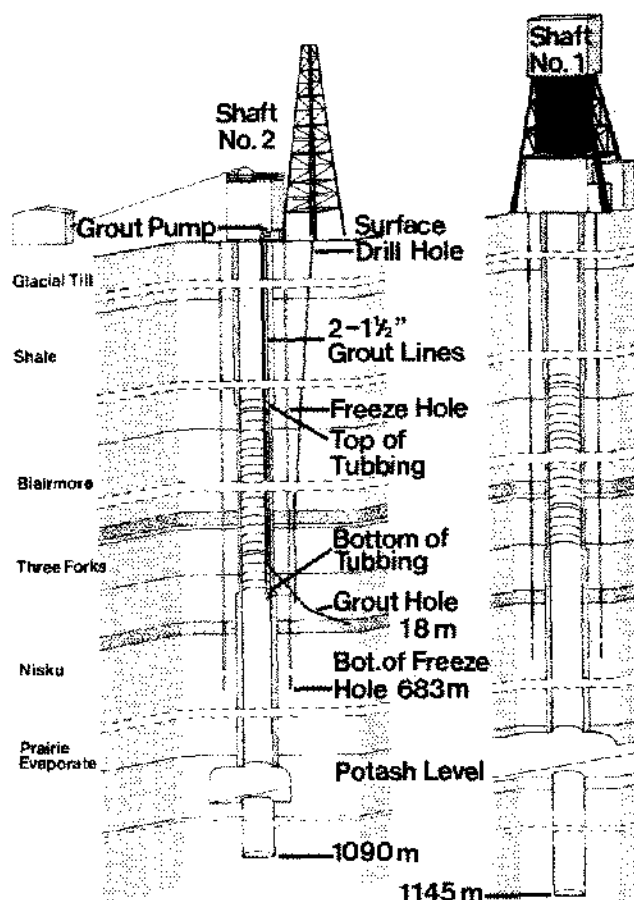
Figure 4. Shafts No. 1 and 2 and surface drill hole.

cut the telephones located throughout the mine. Since the location and elevation of all telephones were known, it was possible to calculate the rate of water inflow by monitoring the telephones. It then became obvious that the available time was not sufficient to seal the break from within the shaft only, and it was decided to drill a relief hole from the surface (Fig. 4).

An oil rig was mobilized and set up to drill a relief hole from surface to intersect the area of the break. Because of room restrictions the hole was spudded 9 m away from the freeze hole circle. It was therefore drilled on an angle towards the shaft and then deflected to come to within 60 cm of freeze hole No. 18 at a depth of 639 m. Moving the drill rig to the site, setting it up, drilling the hole, deflecting it with turbines and installing a casing, took six days. By this time the water in the shaft had risen over the break. After completion of the hole to 650 m and installation of a casing to 637 m a charge of 5 kg of explosives was placed at 639 m and detonated. Pumping tests showed that the blast had created a connection between the surface relief hole and the shaft.

The water had now reached a level of 338 m and 275 m in No. 1 and No. 2 Shafts respectively; the difference of 63 m was due to the different specific gravities of the brine in the two shafts. Brine was pumped into No. 2 Shaft to overcome the formation pressure and to reverse the flow through the breach. When the brine level in Shaft No. 1

reached 272 m this had been accomplished and a drop in the brine level indicated a flow from the shaft into the formation. Now cement was injected through the two grout lines in the shaft. The brine carried the cement with it into the formation. Twenty-four hours later, cement and small amounts of sand, bentonite and calcium chloride were pumped into the surface relief hole to plug the breach in the concrete shaft lining behind the steel plate. 2.2 t of cement were injected into the formation through the two shaft grout lines and 615 t of cement was pumped in through the relief hole to seal the concrete lining and stabilize the ground around the shaft. Through two additional surface relief holes, 17.2 t and 2 t of cement respectively were injected into the formation.

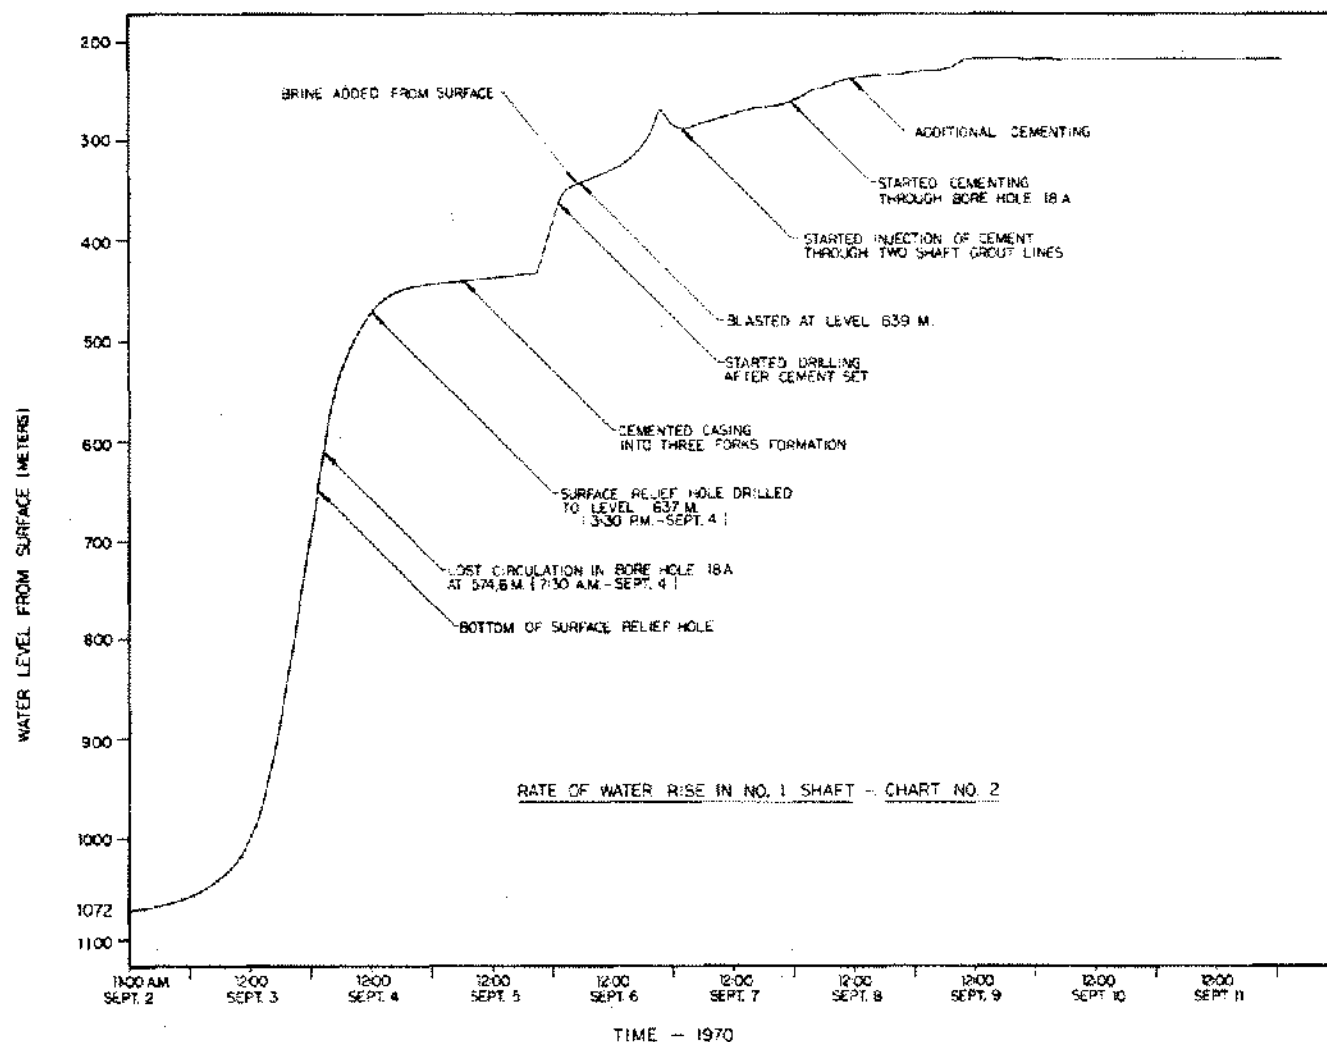
Shortly after the initial cement injections the water make in the shafts was reduced considerably, as can be seen from the inflow chart (Fig. 5) and it could be assumed that the breach in the concrete lining had been sealed.

Figure 5. Rate of water rise in No. 1 shaft.

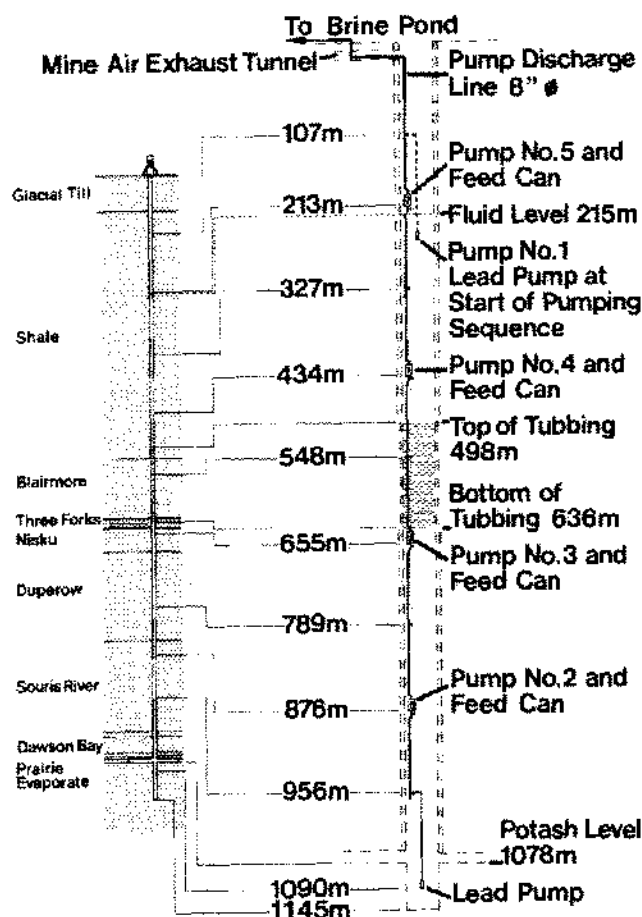
Figure 6. Pump set-up in Shaft No. 1.

2,300 volts and a capacity of 3.5 m<sup>3</sup>/minute at a head of 250 m. Three auxiliary hoists, several winches and a pump discharge line to the surface brine pond were installed before dewatering could begin on September 22nd (Fig. 6). On that day, the water level was 215 m from surface in No. 1 Shaft and 178 m in No. 2 Shaft.

A Byron Jackson lead pump and a 200 mm discharge pipe 137 m long were attached to a hoisting rope and could be lowered and raised by an auxiliary hoist. The upper end of the discharge pipe could be connected to a T-joint in a pump line mounted on the shaft wall. The lead pump was submersed and as the water level dropped, the 200 mm pump line was extended and bolted to brackets in the shaft lining. At a depth of 213 m the first stage pump was installed. This was a Byron Jackson pump mounted inside a closed pipe can, 900 mm in diameter and bolted to the shaft wall. The lead pump assembly was then lowered and the discharge line connected to the first pump can. This proce-

dure was repeated and three more stage pumps were installed at 434 m, 655 m and 876 m below surface.

This system worked well except for the considerable problem of water-proofing the 2300 volt cable connection to the Byron Jackson pumps due to the brine conditions and the pump vibrations.

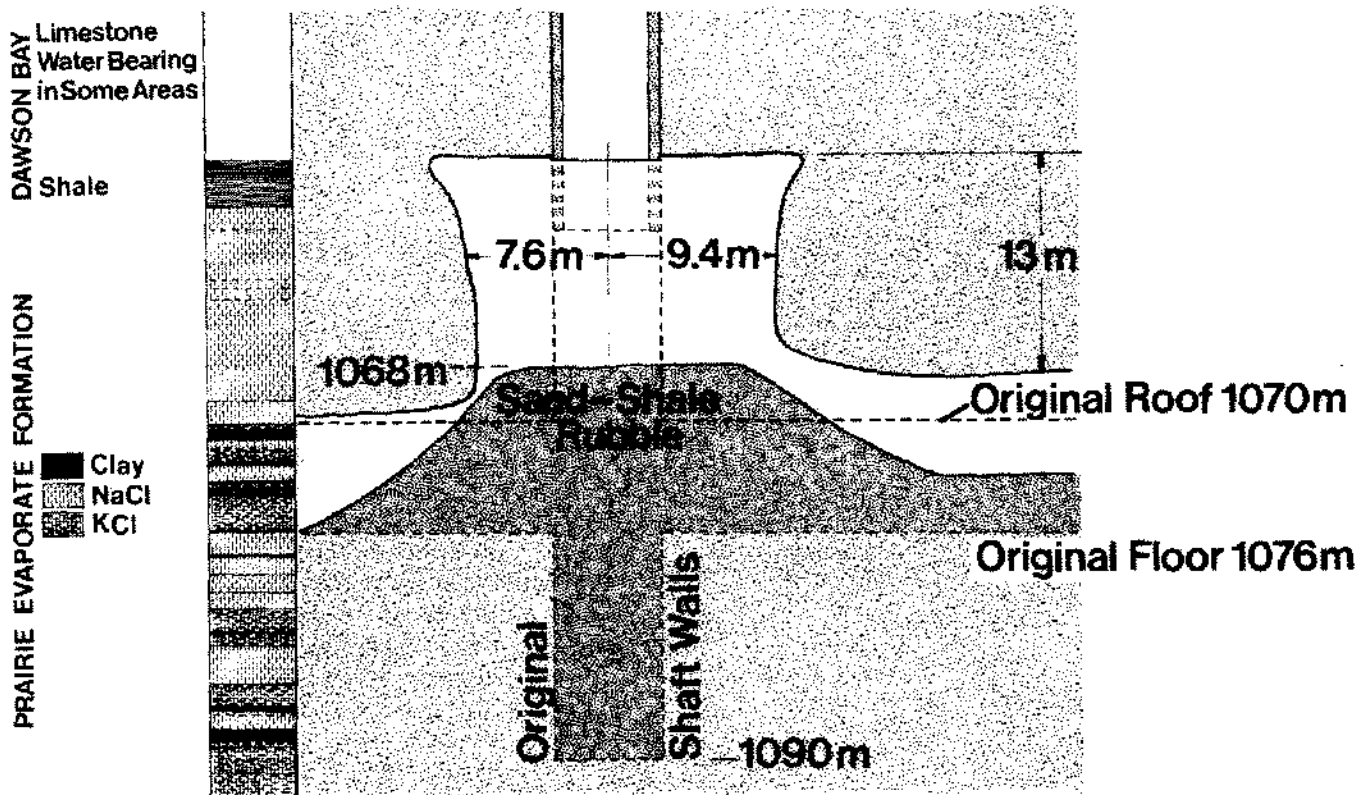
The drifts in the immediate shaft area were checked and secured from a small raft. Heavy leaching had occurred only in the drift through which water had passed from No. 2 to No. 1 Shaft. About 1 m of salt and potash had been washed away from walls and roof. Erosion was especially pronounced where roof bolts had been installed, but was most severe in the area of No. 2 Shaft. The original opening around the shaft bottom had been enlarged to a cavity 17 m in diameter. A platform was constructed to permit work on the roof (Fig. 7).

Figure 7. Washout at bottom of shaft No. 2.
