## Protection of Salt Mines against Water Inflow Threat on the Example of Wieliczka Salt Mine

A.Gonet, S.Stryezek, A.Garlicki and W.Brylicki

University of Mining and Metallurgy, al. Mickiewicza 30, 30-059 Krakow, Poland

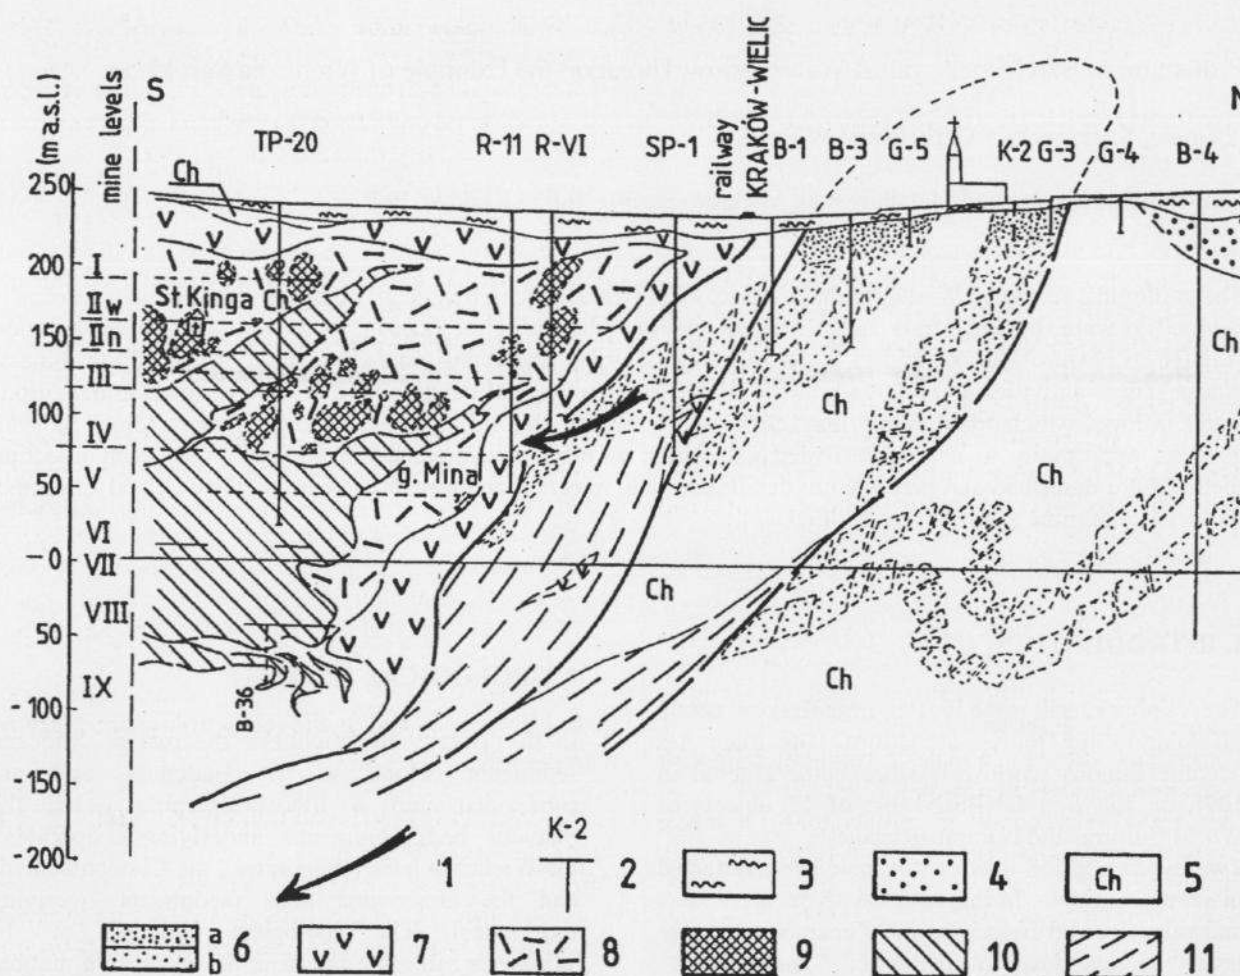
Figure 1. Cross - section in vicinity of gallery Mina (after Brudnik & Szybist, 1995)

1 - direction of inflow, 2 - borehole, 3 - Quaternary, 4 - Grabowiec beds, 5 - Chodenice beds, 6 a - Chodenice sandstones (6 b - upper part weathered), 7 - gypsum cap - rock, 8 - marly claystones of brecciated deposit, 9 - blocks of salt, 10 - spiza salts, shaft salts and green layered salts, 11 - Skawina beds (partly with flysch sediments).

Figure 1) has been broken in places and needs tight reconstruction. These works together with liquidation of abandoned room workings create favourable conditions for reconstruction of a tight inner pillar in the mine.

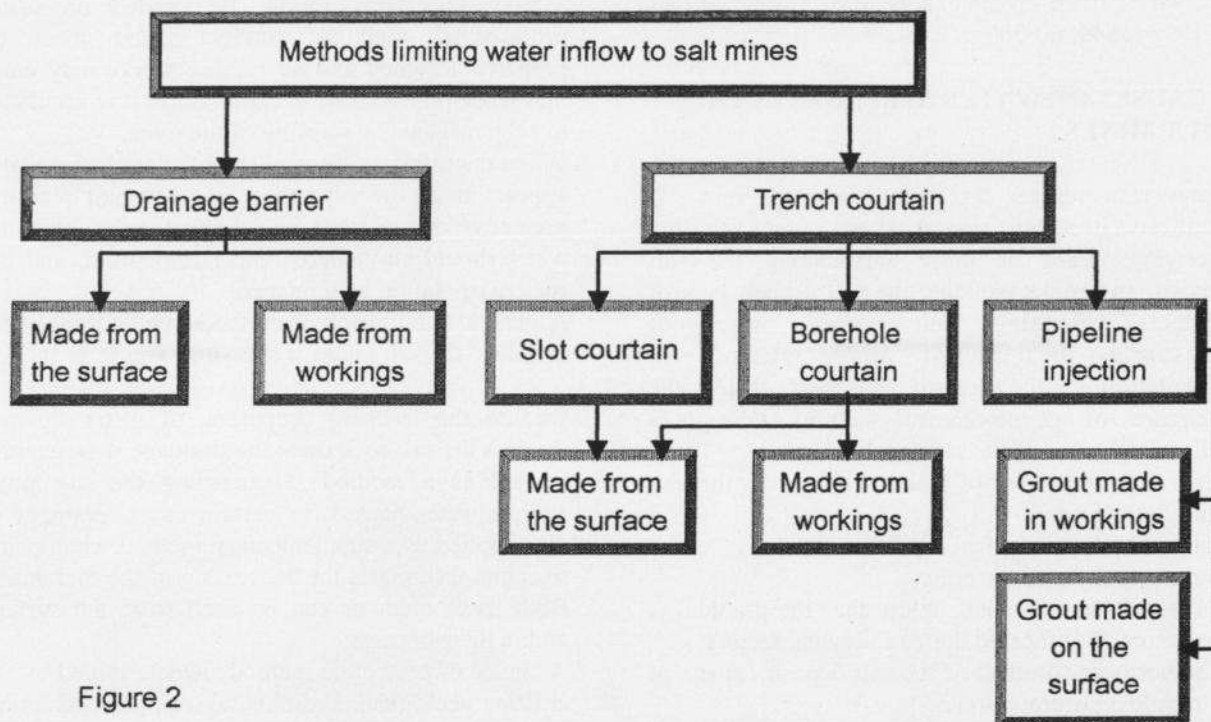
Figure 2

A general subdivision of methods which limit water inflow to the salt mines is shown in Figure 2.

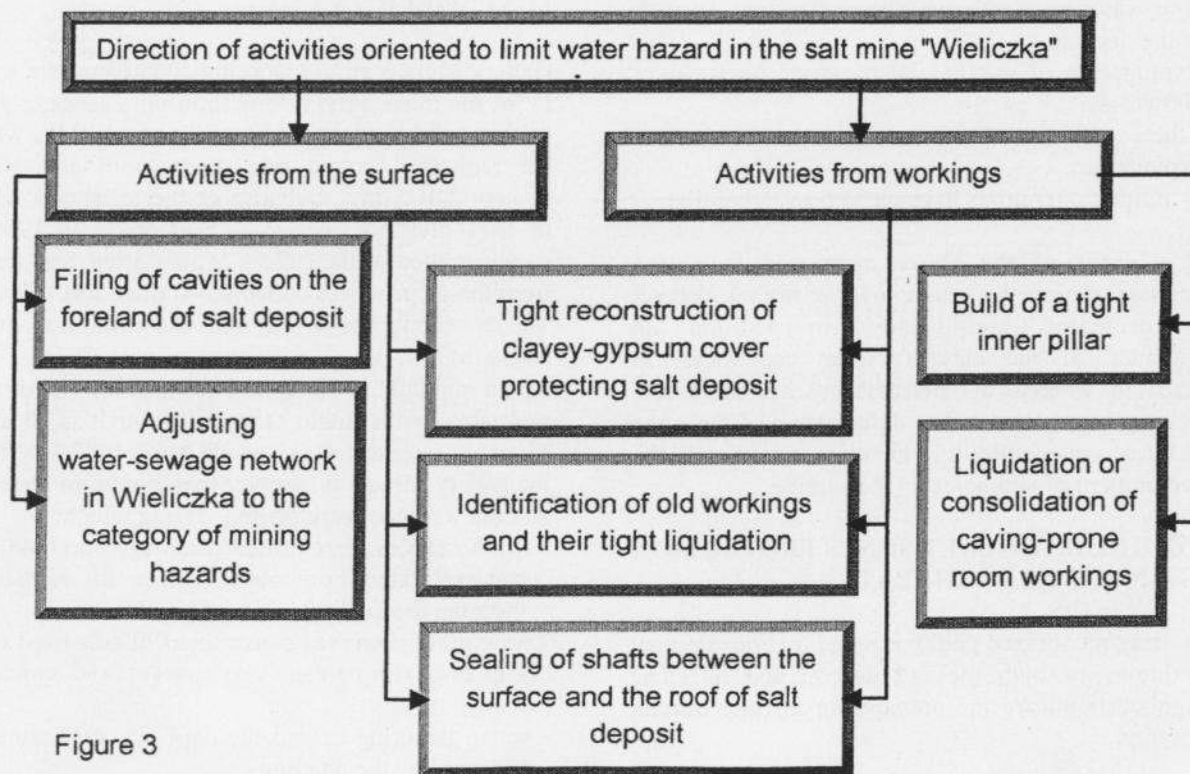
Figure 3

On the foreland of salt deposit the following phenomena were observed on the surface: subsidence exceeding 1500 mm, undulation and deviation of the railway rails, fall of the wall surrounding a monastery of Reformates and another damage of the abbey buildings, origin of the cracks and fissures within the Quaternary strata, damage of existing water-sewage system. The mentioned cracks and clefts have been filled up with clay and grout. The water-sewage system has to be rebuilt with special reference to revealed mining damage and existing geomechanical conditions (Fig. 3). The clayey-gypsum cover (gypsum cap-rock shown in

For the rescue of the salt mine "Wieliczka" various protection works have been carried out. A general outline of these works is shown in Figure 3.

Basic works protecting the mine are injections for consolidation, tightening and stability of the rock mass. Drainage boreholes are auxiliary to create better conditions for injection works, and therefore to improve the safety of the mine.
