The Control of a Brine Inflow and Support to the Resulting Solution Cavern in a Conventional Saskatchewan Potash Mine

A. D. Mackintosh^a and W. C. McClung^b

In 1985, Agrium's potash mining operations, then known as Cominco Fertilizers Inc., experienced a roof failure followed quickly by a brine inflow at the end of an abandoned mining panel. Over a decade was spent rehabilitating openings into the area, carrying out exploration drilling to determine the source and brine flow patterns, and finally to successfully control and grout the inflow. Drilling outlined a number of discrete flow paths in the overlying limestone which, when relieved through cased drill holes, stopped the uncontrolled flow into the mine and allowed grouting around the inflow site using cement and flyash mixtures, ultrafine grouts and chemical grouts to take place in a "no flow" condition. Although the location of the inflow was known, it was several years before access was actually gained, through difficult ground conditions, to allow monitoring the effectiveness of grouting operations. During this period a large solution cavern over 30m in diameter and 20m in height had developed. Approximately 4m of the ove

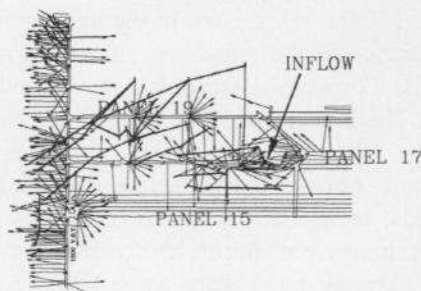
Flow tests carried out on a number of the holes indicated discrete pathways trending in a NE - SW direction. There was good communication between holes along this trend but very poor communication in the NW - SE direction.

Figure 1. Inflow, drill holes and pathways.

Flowing a hole on one pathway would significantly reduce the pressure and flow on holes on the same path but had little or no effect on holes on adjacent parallel pathways. Also, when the flowing hole was again shut in, the pressures on connected holes took some time to recover indicating it was possible to draw down the area.

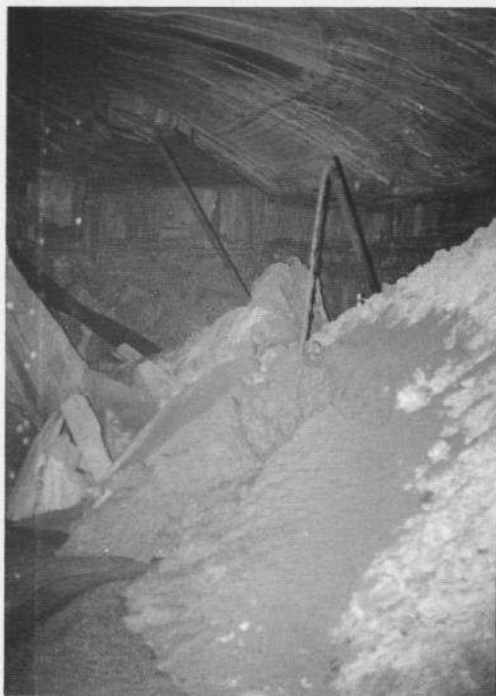
Figure 2. Filling from casing.

Three HW holes were drilled from the mine level up into the cavern. A casing shoe allowed drilling to continue through the loose rubble and the casing could be pushed up close to the back. Filling took place through the casings using a concrete pump and mixing station set up on the mining level. Pumping distance was approximately 100m. Two 250mm dia. HDPE pipes were also drilled into the cavern as exhaust ports for air coming up the culvert. Backfilling started by pumping up a cement slurry without any aggregate in an attempt at filling void spaces and consolidating the rubble.

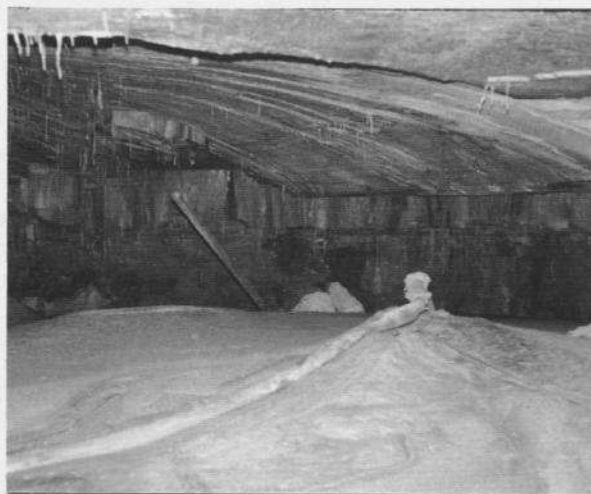
Figure 3. Fill and distribution hose.

content providing strengths of between 4 and 5.5 MPa were used for most of the filling. The final 3.5m was filled with material containing 20% cement having strengths of 6.5 to 7 MPa to provide a stronger floor beam for supporting packs. By moving between holes it was possible to achieve a relatively flat floor. Twice the access culvert had to be extended in 2.4m increments. As the fill approached the intended height, a hose could be attached to the casing and the saltcrete distributed around the cavern to help level the floor.

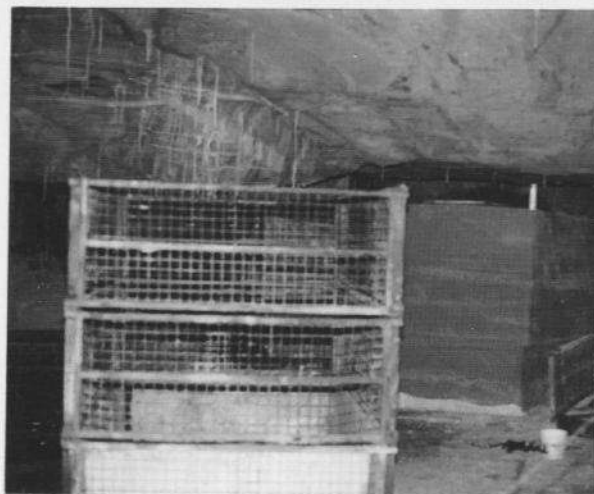
Figure 4. Mesh form and completed support.

Once the backfill was to the desired height, saltcrete pillars or cribs were poured to provide support to the back.

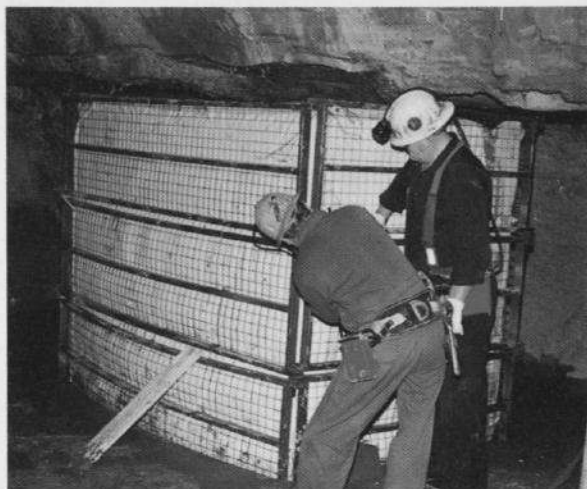
Figure 5. Completed form and fabric liner.

Forms constructed of steel tubing and wire mesh in .6m by 2.4m and .6m by 1.5m rectangles were hoisted up the culvert manway and pinned together to form a 1.5m by 2.4m rectangular form, 1.8m to 2.4m high.

A fabric bag was sewn to fit into this form and saltcrete was again pumped through the casings and hose to fill these bags.

The forms would be half filled then allowed to set before continuing to final height to avoid stressing the forms or breaking the bags.

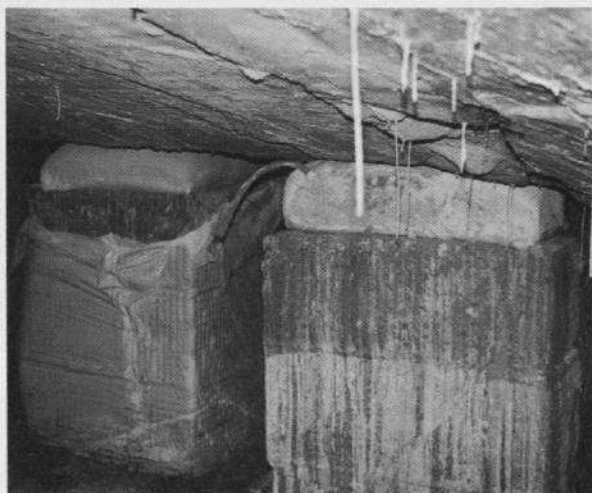
Figure 6. Completed support.

The filled bags conformed to the contours of the back. It should be pointed out that the ground temperature is 30.5° C. While these supports were being placed the curing cement raised the temperature to over 43° C resulting in a difficult working environment.

Custom fabricated geotextile bags designed to accept cement were then placed on top of the pillar and pumped full of thick cement slurry.

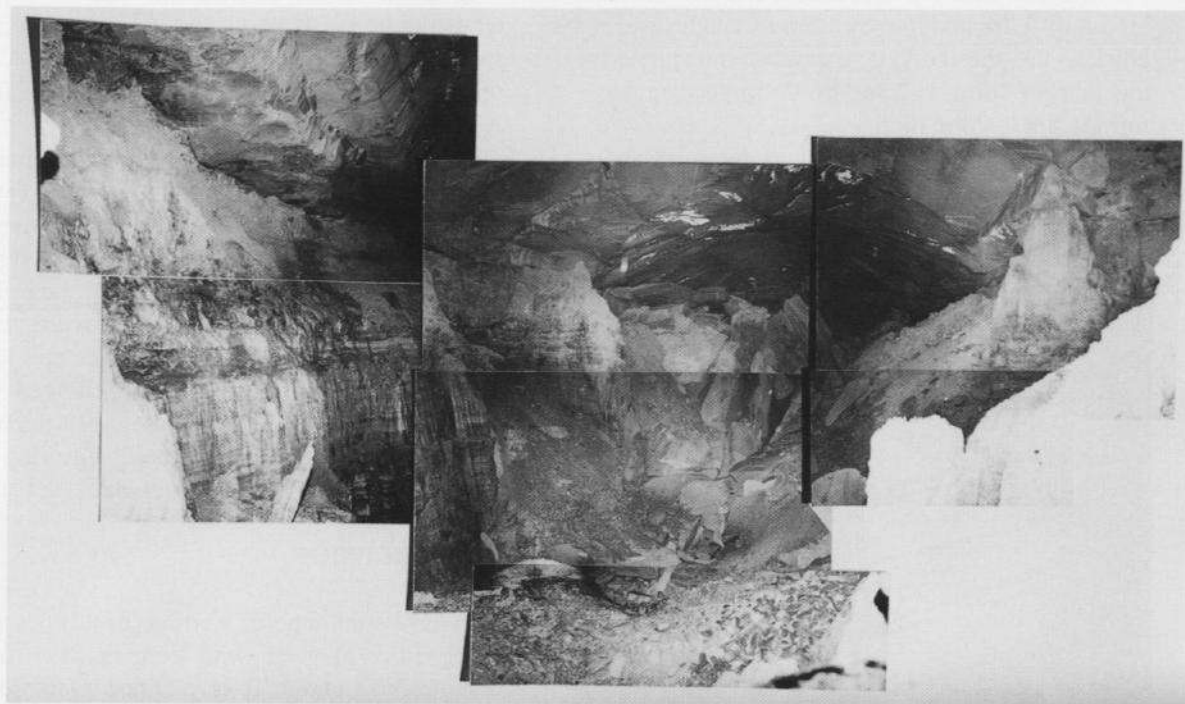
An Alpine AM-50 was used to re-cut panel 17 room 2 from the West towards the turnaround area. As cutting approached the turnaround, a sink hole or vertical chimney feature was encountered where brine had dissolved a semi-circular channel in the overlying salt. This chimney was approximately 1.2m by 1.8m and appeared to go straight up to the overlying limestone. A .9m diameter culvert with internal rungs was installed in order to gain access to the top of the salt. It was expected that the collapsed salt covered by 2nd Red Bed rubble would be found which could be cleaned up to provide a workable floor to access any cracks which could be monitored and possibly chinked should they leak grout. Instead, the culvert emerged about halfway up a huge cavern, 33.5m across and almost 20m in height. The collapsed salt had been completely dissolved and the bottom of the cavern filled with the 2nd Red Bed rubble and blocks of limestone. The back formed a smooth arch with the highest point approximately 3m into the limestone. The inflow brine could be seen running from numerous joints in the limestone.

Figure 7. Cavern as seen from the manway prior to filling.

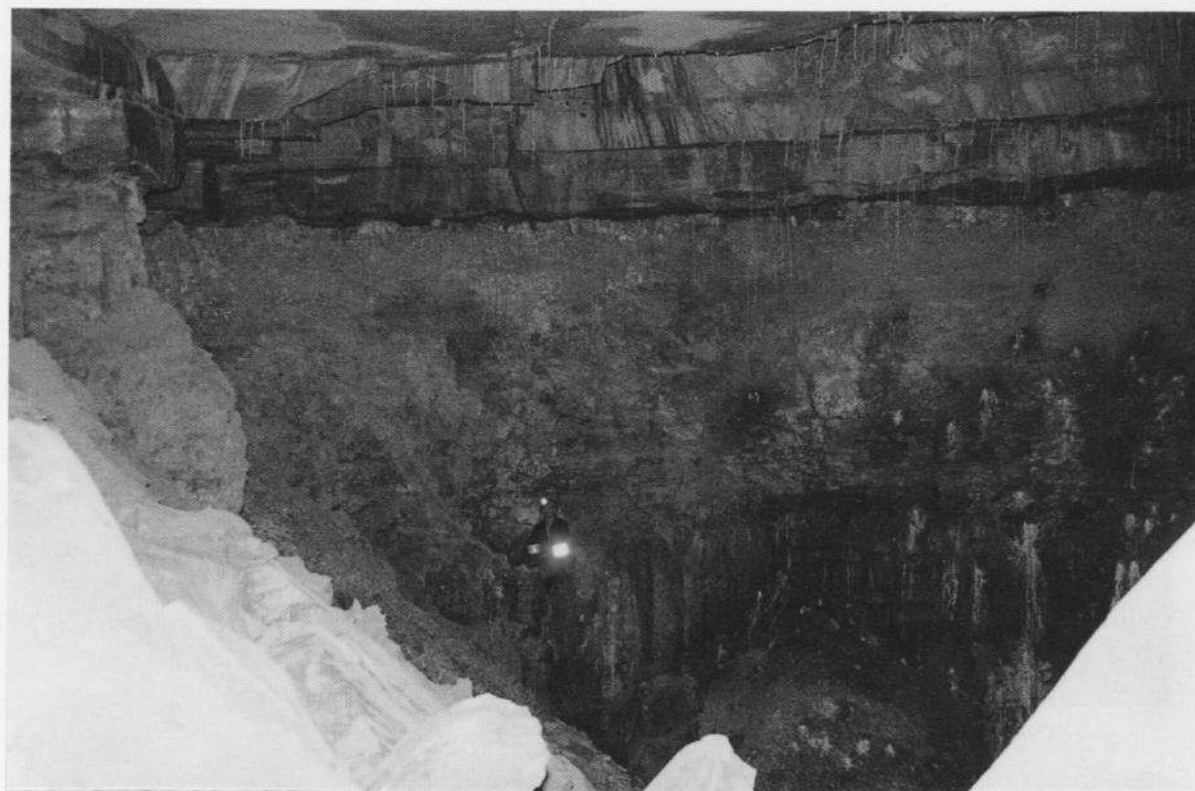
Figure 8. Cavern and manway taken from figure 7.
