Use of Protective Coatings in Salt Mine and Plant

by
Kenneth Tator
Kenneth Tator Association
Coraopolis, Pennsylvania

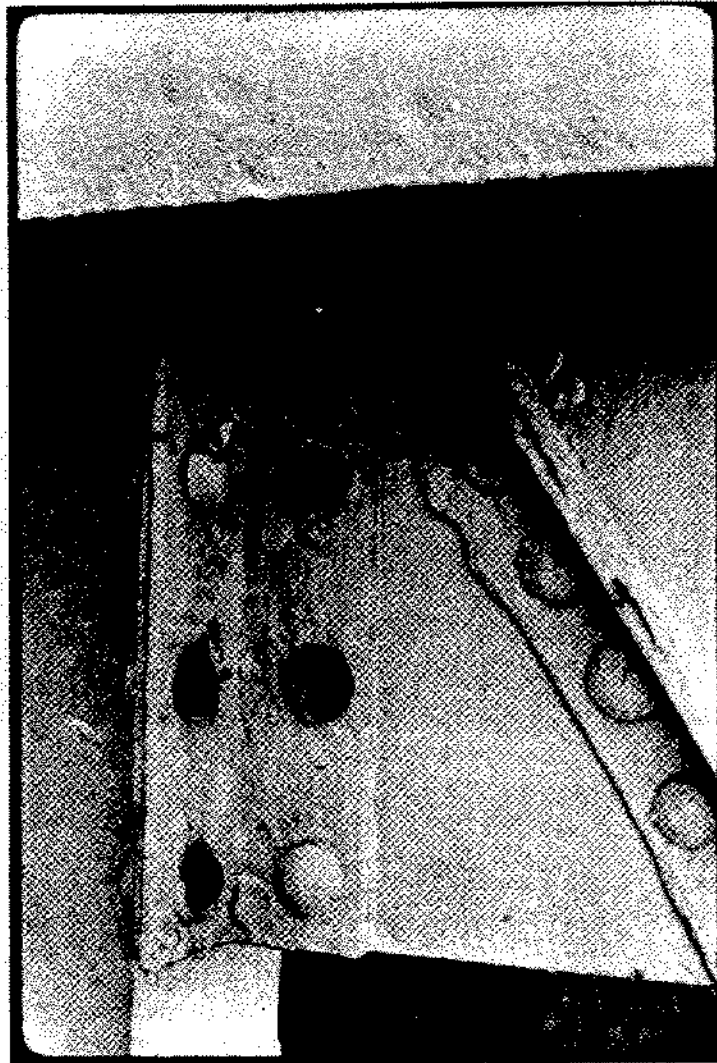
Figure 2.

Failures so starting at such point sources rapidly spread from these points of initiation to destroy, by undercutting the paint protection in the immediately surrounding areas (Figure 2). As long as this process of spreading from the points of initial failure is not detected and stopped by intelligent maintenance attention, this undercutting and spreading process will continue until paint protection is lost in large surrounding areas (Figure 3), until complete paint protection is lost (Figure 4).

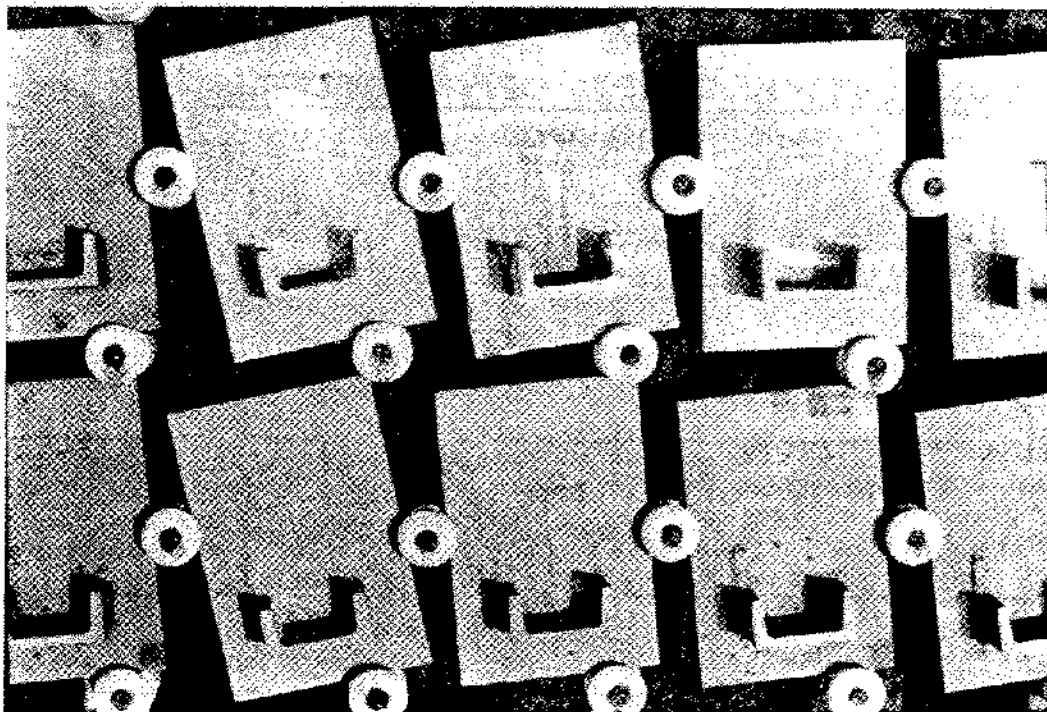
Figure 6.

As a word of caution, it must be pointed out that while all zincs are beneficial, there will be considerable variation in performances with the type and form of zinc selected. It is therefore suggested that the zinc used be chosen with intelligence, from the varieties of galvanize, metalize, and the various zinc-rich coatings available. Figure 6 shows the range of variation in performance of various zincs under the same organic coating.

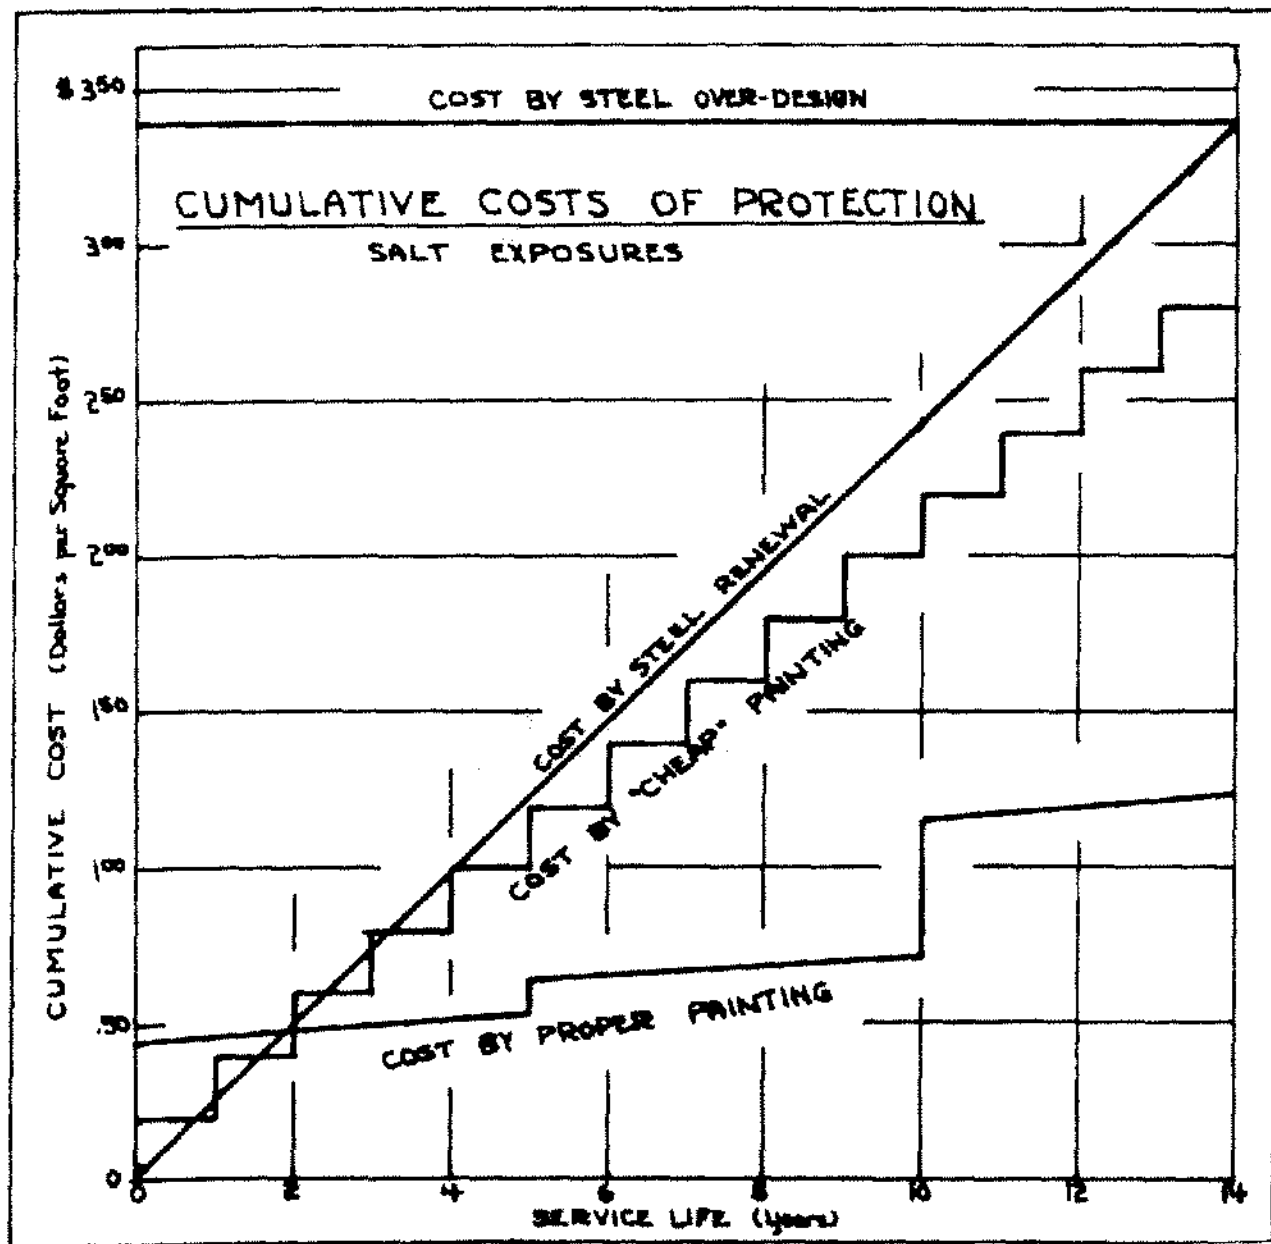
Figure 7.

"Oh, but that's a lot of trouble," I can hear some of you say, "that's an expensive procedure, and we don't have the money and personnel to carry out that type of application and spot repair, and we can't afford to set up to do it just for the sake of painting the plant." You can't afford not to do it! Figure 7 shows, in the step-curve, the cost of casual painting, which over a fourteen year period amounts to \$2.80 per square foot of surface protected. The diagonal showing a final cost of \$3.40 per square foot is the average cost of your fabricated and erected plant steel which will be lost and must be replaced if it is not protected from salt corrosion. The horizontal line at the top ending at this same cost is that cost to your plant if you over-design all steel members and equipment to provide a corrosion allowance, which can be corroded away during the design life of the structure or equipment without impairing the required load-bearing strengths. The lower curve showing the lowest cost of \$1.20 per square foot is the cost of doing what we recommend: properly applying a properly selected coating initially, and then placing it on regular inspection and spot repair during its entire service life. You will notice the initial cost of the paint application is over twice the cost of your present paint application, but this initial premium is returned after the first two years of service.
