# Thermally induced cracks in gas caverns in rock salt

# Fractures in gas caverns in rock salt

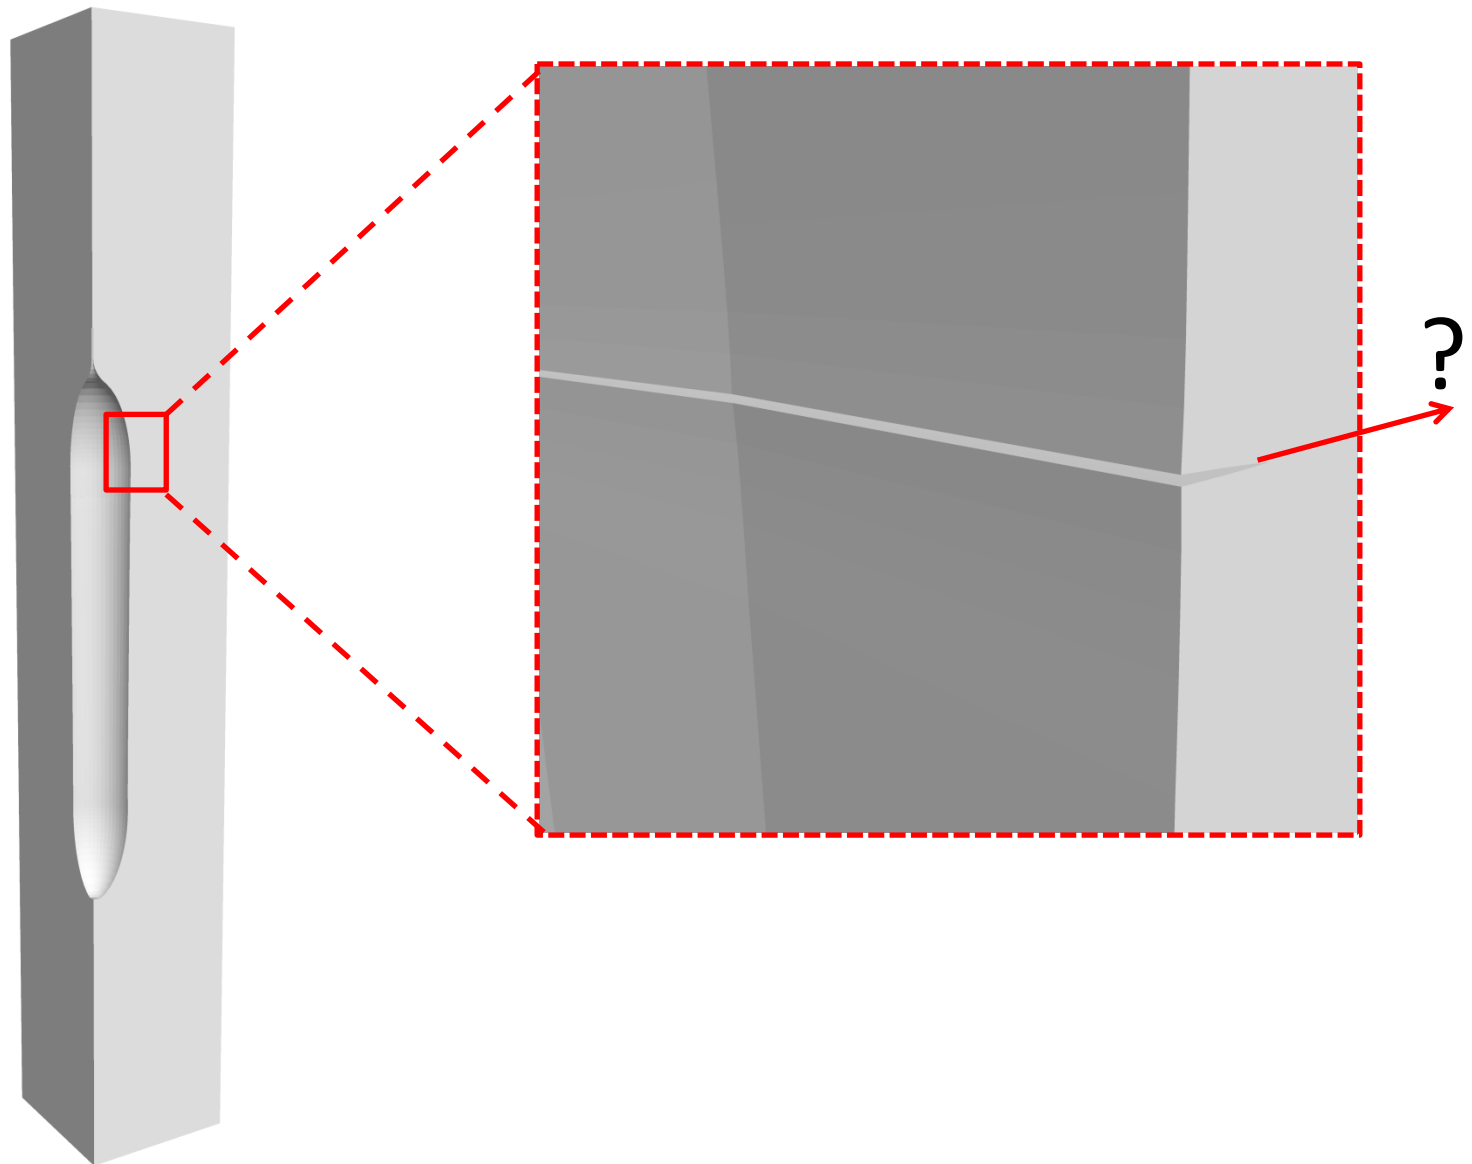
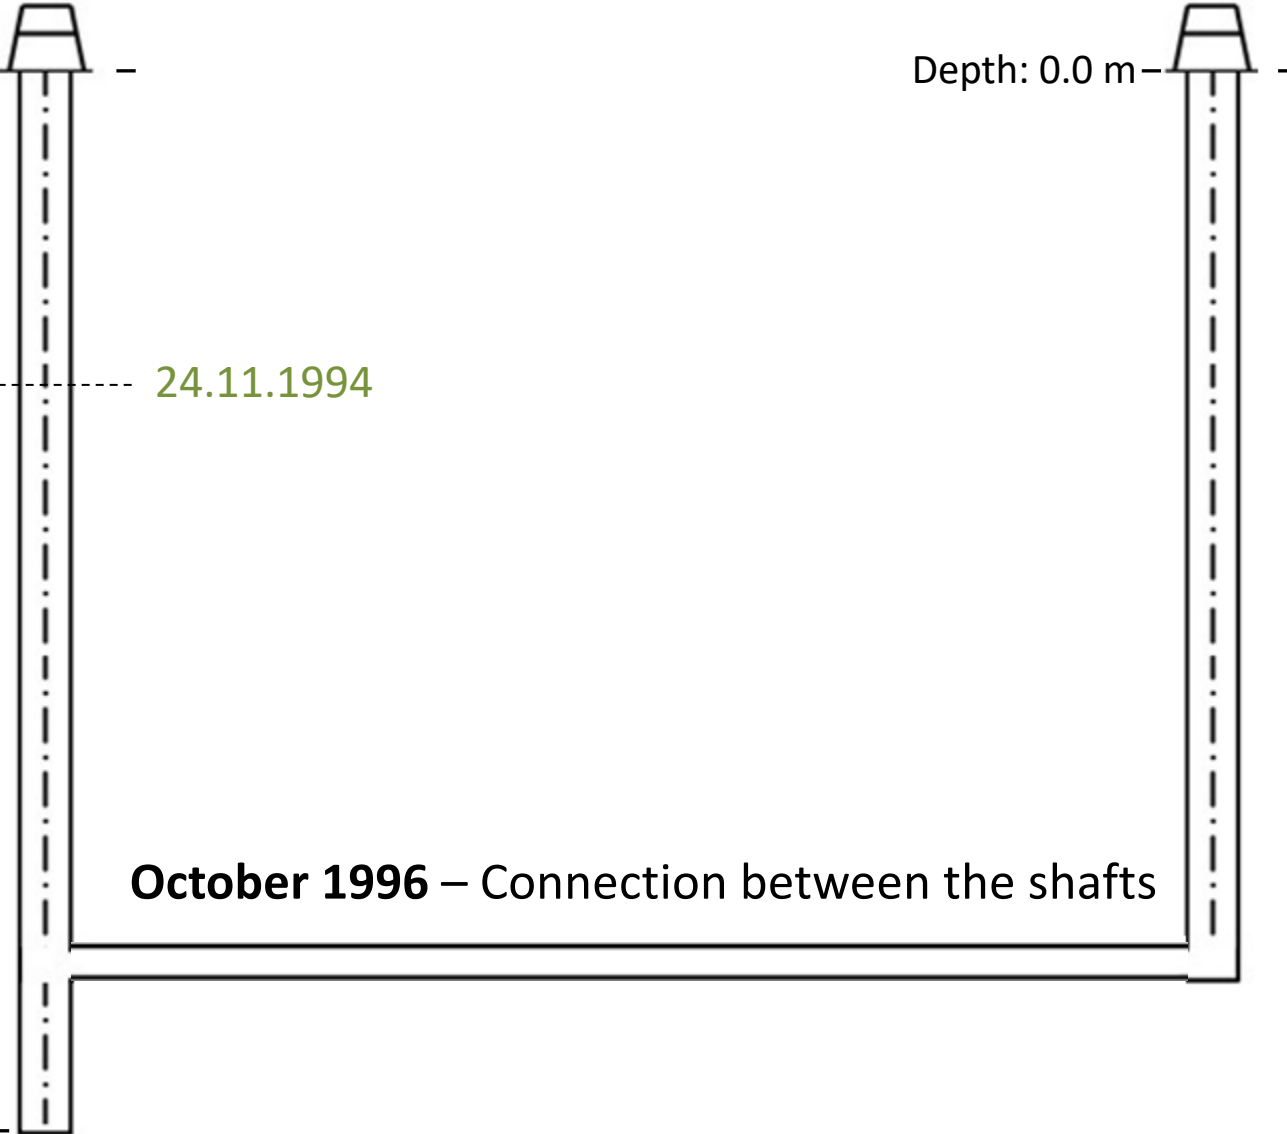
## Example 1: Shaft in a salt mine in Germany

**October 1996** – Connection between the shafts

Depth: 907.0 m

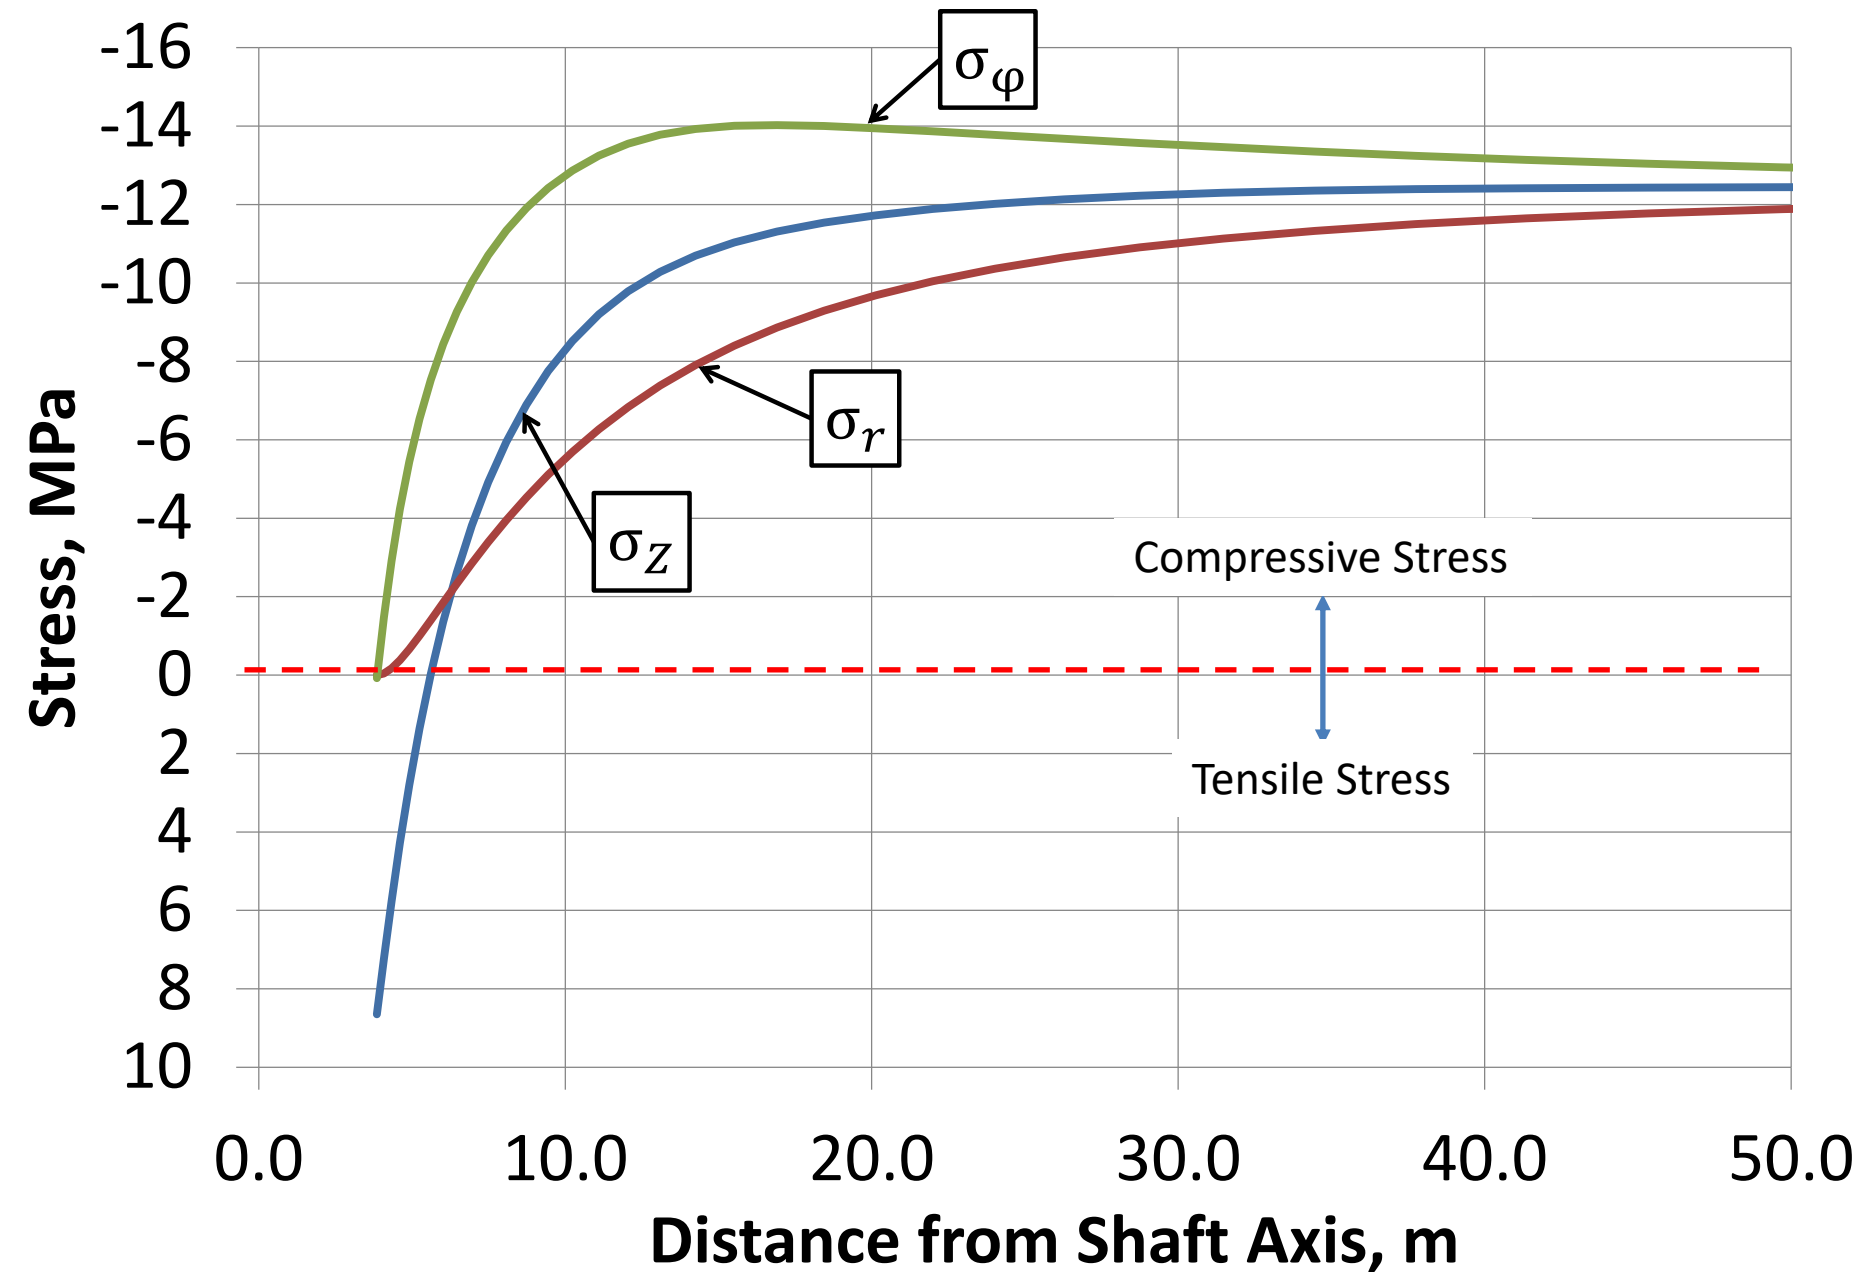
# Principal stresses after temperature decrease

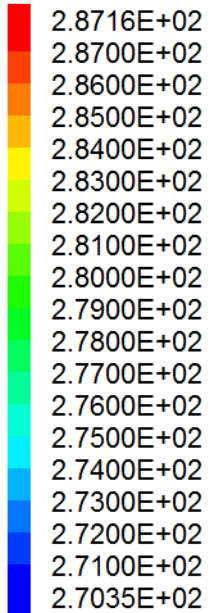
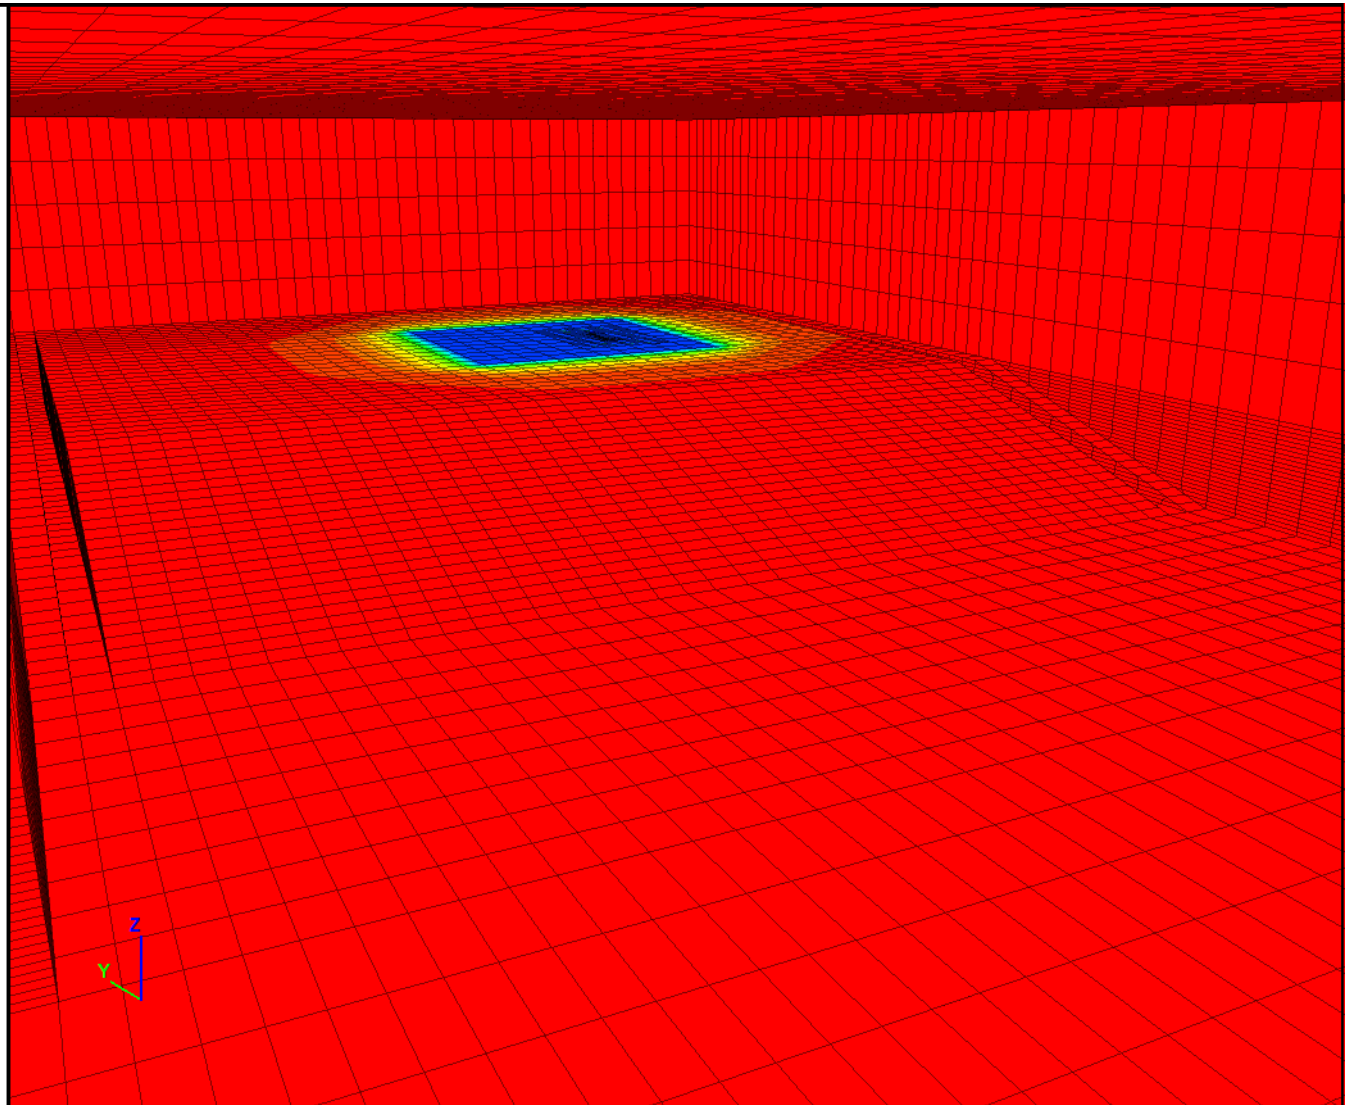
# Numerical investigations of the temperature distribution

### **Contour Of Temperature**

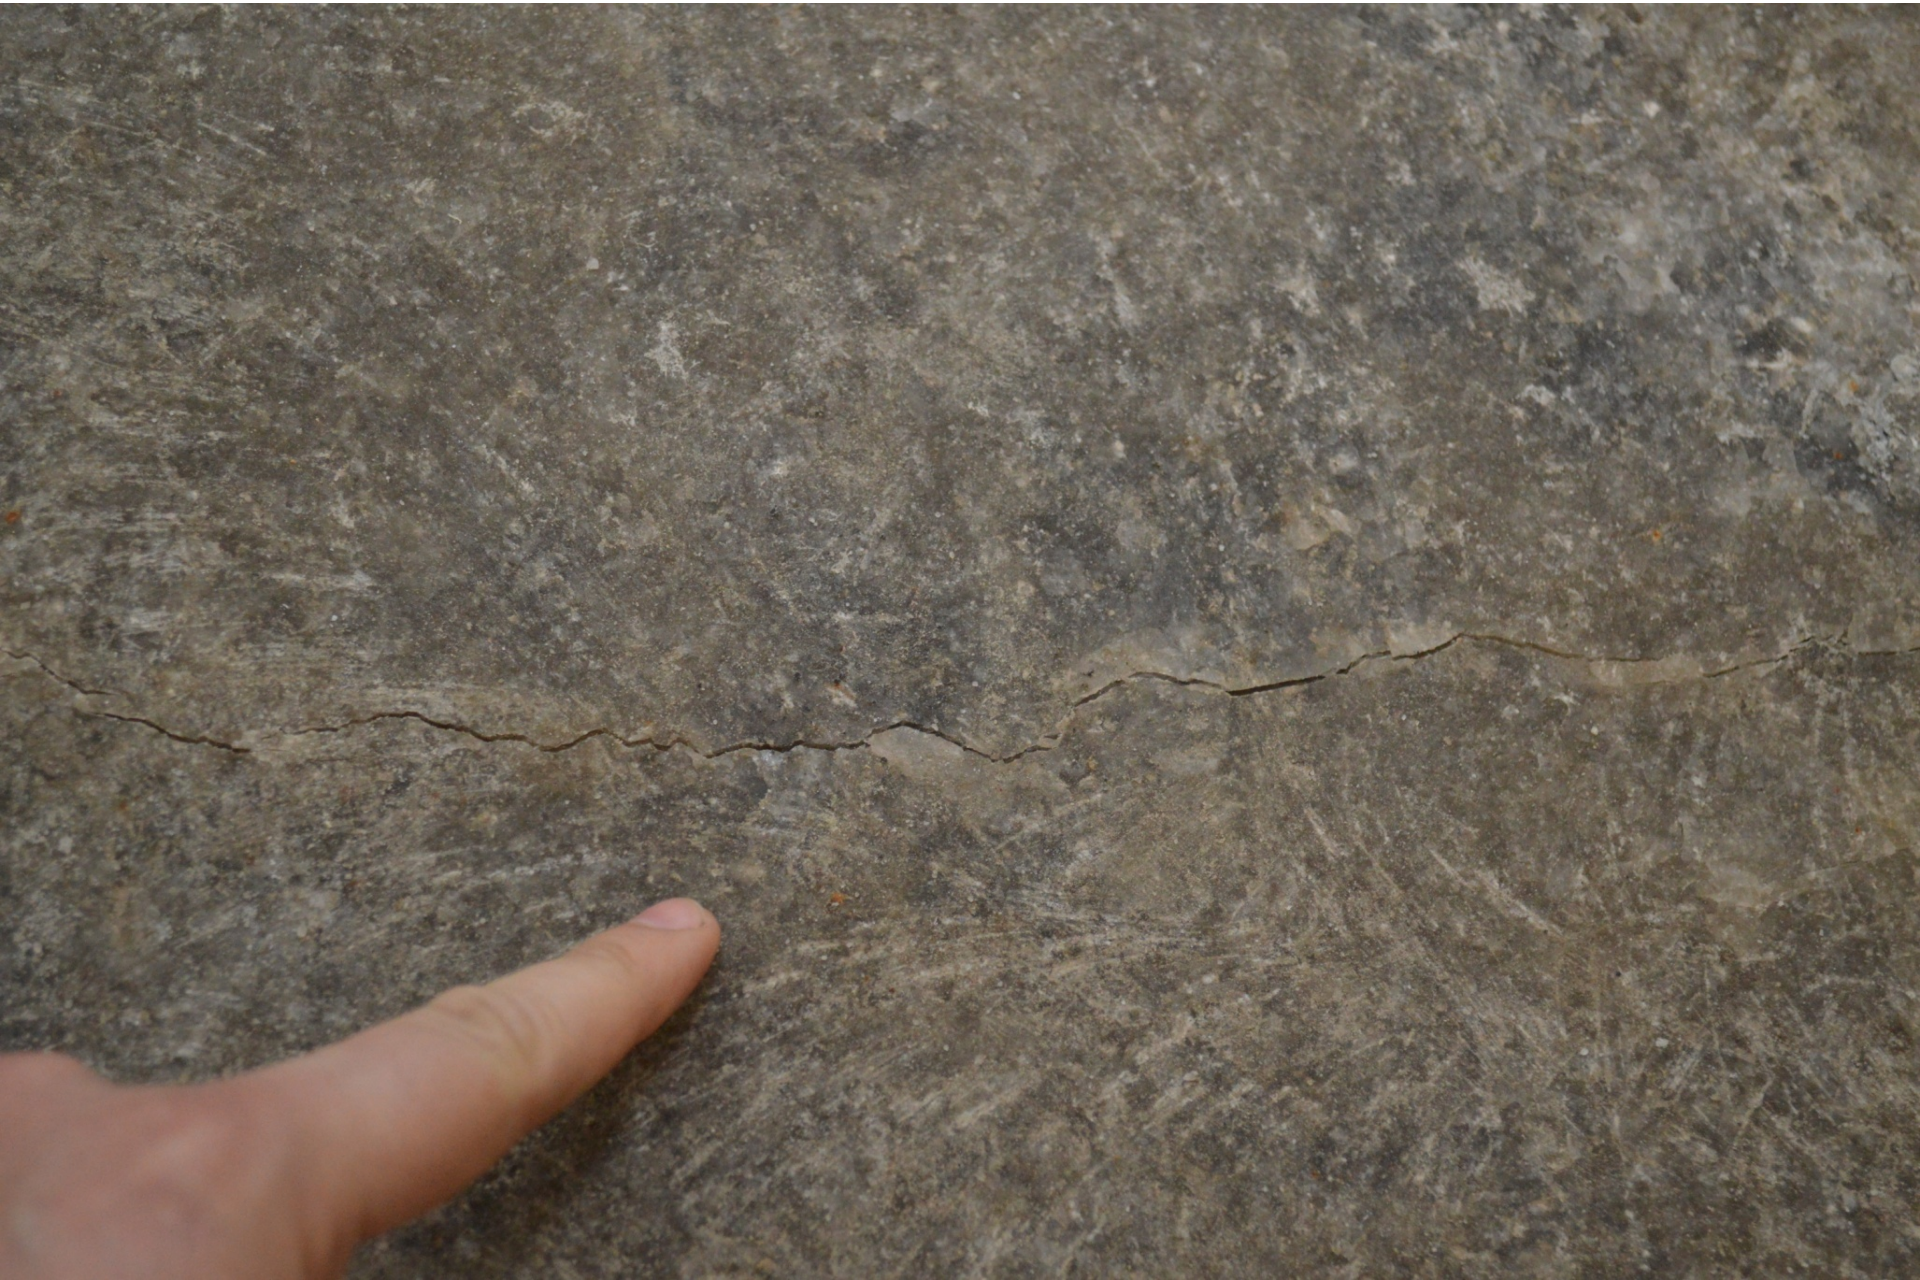
Observed macroscopic cracks in the rock salt
